TO: All Prospective Bidders
FROM: Tanya Hazlett, Procurement Advisor *TH*
SUBJECT: ADDENDUM NO. 2
**PWC2223039 – RFQ / DESIGN-BUILD SERVICES LINE 54-
INCH OUTFALL RESEARCH TO I-95**

**PRELIMINARY ENGINEERING REPORT FOR BANK STABILIZATION AND
ACCESS ROADWAY STABILIZATION AT ROCKFISH OUTFALL**

PROJECT NO. 20-90

October 28, 2021

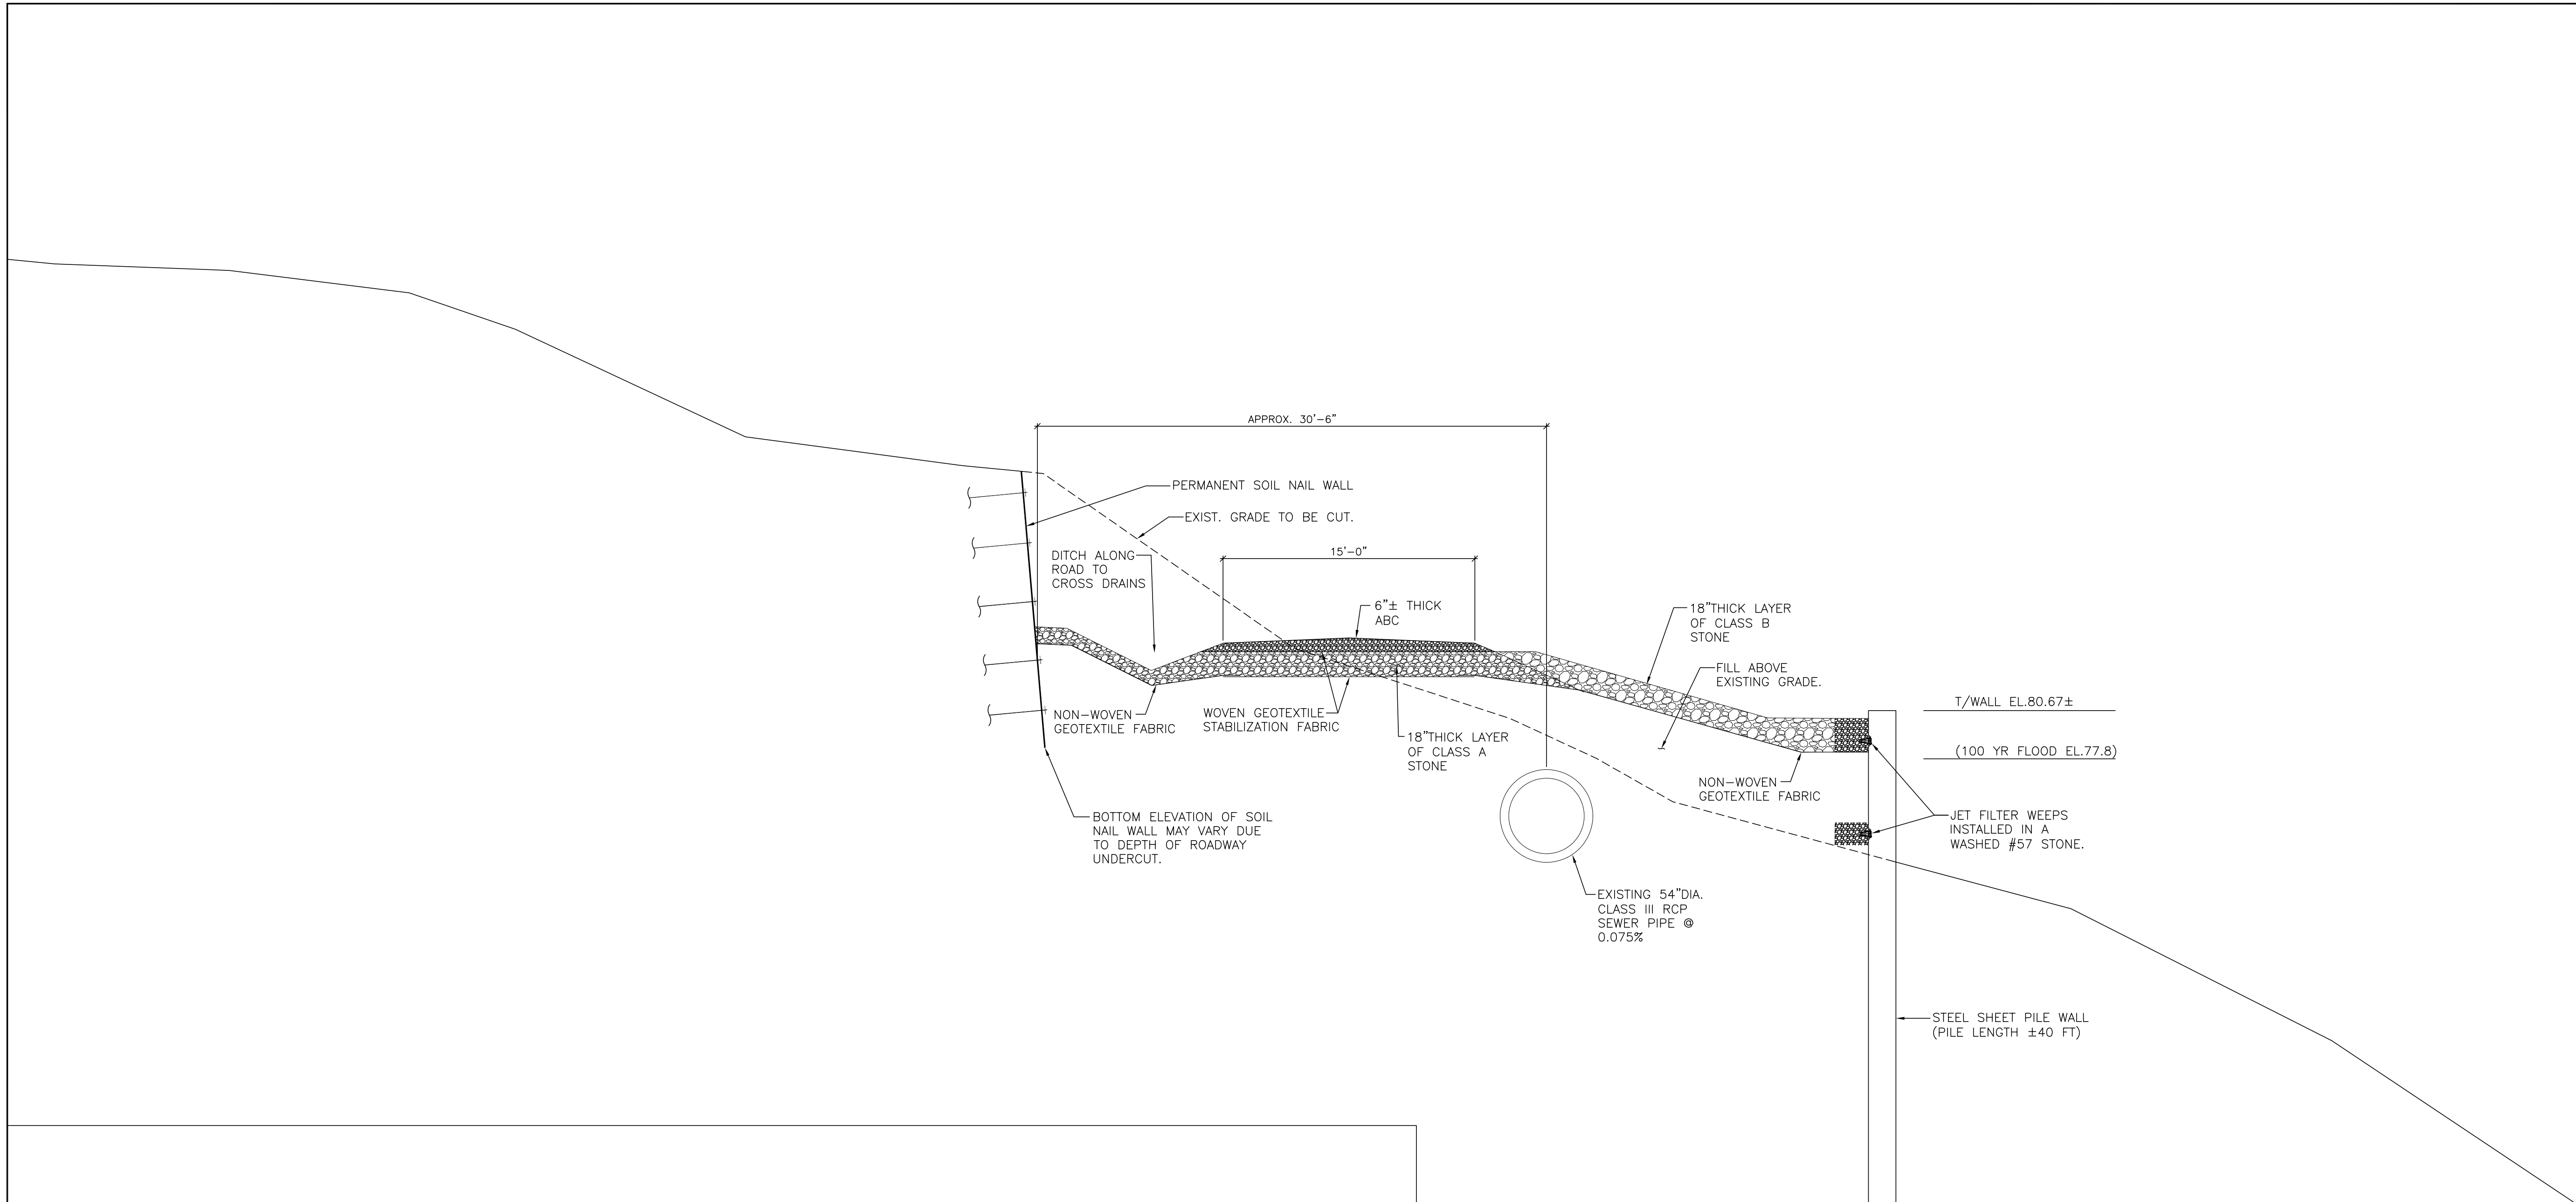
SECTION ALONG ROAD 2
3/16" = 1'-0" S3

The sewer outfall is maintained using an existing service roadway located alongside the sewer line within the 50 feet wide easement. The section of roadway that was investigated for vehicular stability extends from approximately Station 49+00 to the manhole at Station 58+04. The terrain can be described as rolling with a few erosion gullies. The roadway was covered with tall grass at the time of our site visits. There are several areas of very soft soils and shallow water impoundment on the roadway surface. Seven soil SPT borings and three Kessler DCP borings were performed by Building & Earth Sciences along the proposed roadway. Top soil was encountered to a depth of approximately 14 inches at boring B-12 only, however, top soil may also be present in unexplored locations. Very loose to medium dense fill soils were encountered in the majority of the borings to depths of approximately 13 feet. Very loose to very dense naturally occurring sandy soils were encountered below the fill material.

At the time of our site visits, water was ponded in several locations along the proposed easement roadway. The boring data suggest that the ground water may be perched in the earth strata or caused by springs emanating from the adjacent hillside. The water is not likely related to the local groundwater table; however, groundwater seepage may be encountered in locations where undercutting of soft soils is required. The contractor should be prepared to use dewatering methods during construction of the roadway.

The following general recommendations are required to stabilize the roadway for vehicular traffic:

1. Prior to construction, preferably as soon as possible, it is recommended that the roadway be ditched to allow water to drain and the surface to dry as much as possible.

3. Remove all vegetation and topsoil for a 15 feet wide roadway plus drainage ditch. Excess top soil will need to be disposed of offsite.
4. Cut high areas and fill low areas for a smooth roadway.

5. Remove soft soils in fill areas along roadway and place geogrid with engineered fill material to subgrade elevations.
6. Construct a continuous drainage ditch along the uphill side of the roadway. Place geogrid and Class A stone in the ditch.

7. Provide a geogrid and 18 inches minimum of Class A stone below the roadway ABC stone.
8. Install cross drain pipes below the roadway to direct seepage and runoff water from the continuous ditch located on the uphill side of the roadway beneath the roadway. Cross drains will include a combination of perforated HDPE pipe and RCP. The pipe will extend to daylight on the down slope side of the roadway in a bed of dissipator stone.

9. Place final roadway surface consisting of 6 to 8 inches of ABC stone over a woven geosynthetic fabric.

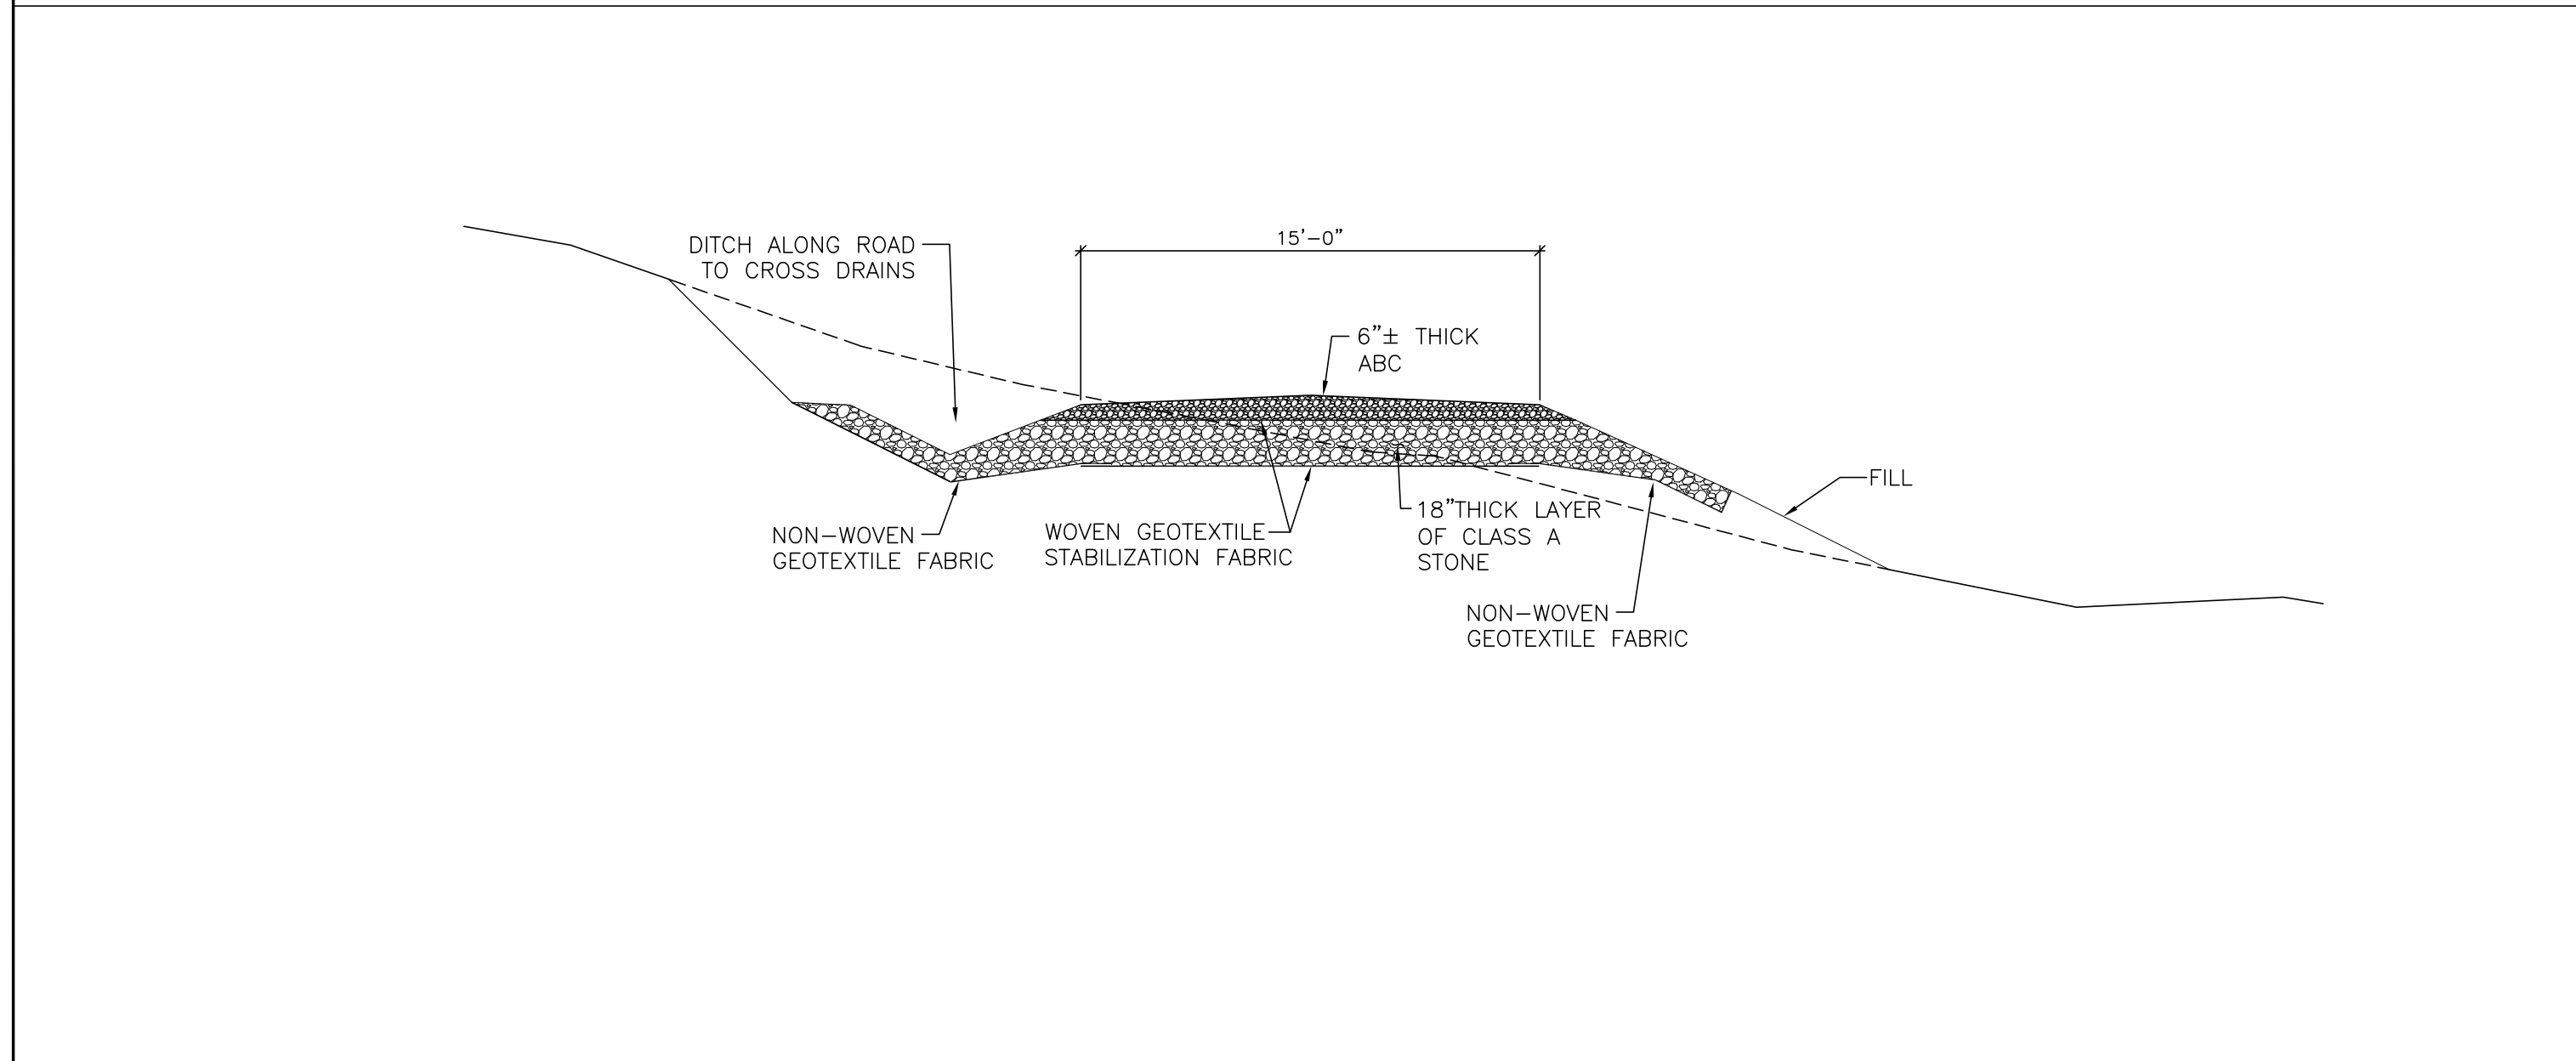
SECTION ALONG SHEET PILE WALL 1
3/16" = 1'-0" S3

The area of bank instability is located at a sharp bend in the creek starting in the vicinity of the existing manhole at Station 58+04 and extending in the east direction to approximately Station 60+04. The 54-inch RCP sewer pipe is located uphill of and within a few feet of the edge of the bank failure. According to the existing drawings dated February 1974 by Rose & Purcell, Inc., the top of the pipe in this area is shallow, two to three feet below original grade and as little as 1 foot below current grade at the lowest point. It is our understanding that the interior of the pipe was recently inspected by camera and that no displacement was observed at the time of the inspection.

Building & Earth Sciences, LLP, performed a preliminary subsurface exploration and geotechnical evaluation (see Building & Earth report dated April 23, 2021). Six 50 feet deep borings were performed along the 200 LF of bank instability. The subsurface investigation indicates that a stiff layer of clay material is located typically 10 ft to 15 ft below the existing grade at the proposed location of the sheet pile wall. A cantilevered sheet pile wall is recommended to retain the soil, thereby stabilizing the bank. Pre-drilling prior to sheet pile installation is recommended to minimize vibration and potential damage to the sewer pipe. Additional subsurface investigation will be required before final design work is completed for the retaining wall, primarily to evaluate long-term slope stability and to identify the effects of instability during the proposed repair effort. Temporary bank stability measures may be required until the sheet pile wall is completed. In addition, we recommend that a sewer bypass plan be developed in the event that the existing pipe is damaged during construction.

The preferred method of stabilizing the bank was determined to be a cantilevered sheet pile wall located on the creek side of the sewer pipe (see schematic drawing, Sheet S3). Construction equipment access to install the sheet pile wall will be facilitated by providing a 25 feet wide level bench on the uphill side of the sewer pipe. A permanent soil nail wall will be required to retain the bank above the bench. The equipment access benched area will also be used after construction as the permanent maintenance access road. The soil removed to provide the construction bench will reduce the surcharge on the sewer pipe during construction and will also likely be used as fill behind the sheet pile wall.
