TO: All Prospective Bidders
FROM: Tanya Hazlett, Procurement Advisor (774)
SUBJECT: **ADDENDUM NO. 3 – PWC2223039 RFQ/DESIGN/BUILD SERVICES
LINE 54 INCH OUTFALL RESEARCH TO I-95**

**Response to Questions
Request for Statement of Qualifications
Design-Build Services Line 54-Inch Outfall Research Drive to I-95**

**54" OUTFALL REHABILITATION
 MANHOLE APPROXIMATE SURVEY DATA**
 FIGURE 1

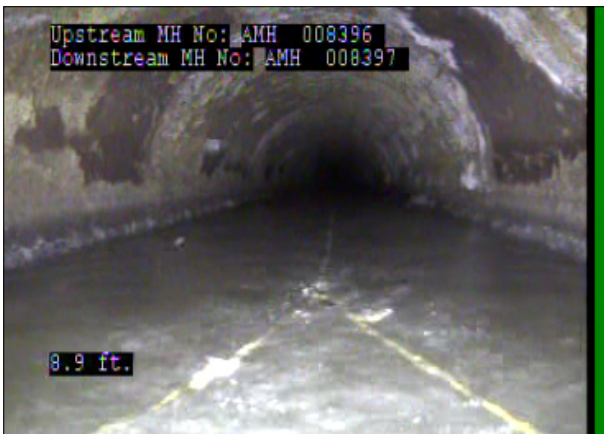
Photo: PWC-2103892-01-AMH '008396'-AMH '008397'-MWL at 0.0 ft.JPG
 0FT, Water Level, 30 %of cross sectional area

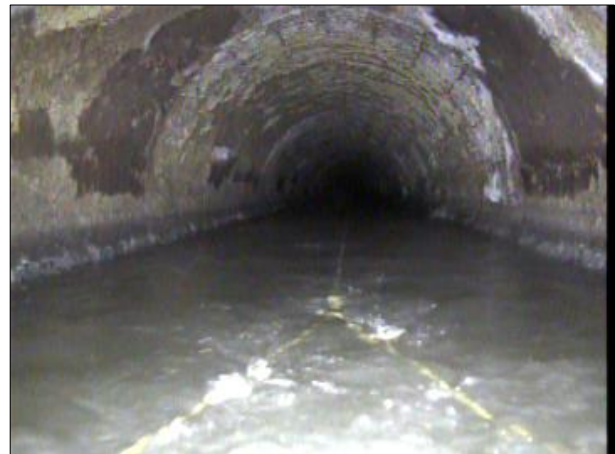
8.90	S1 Surface Reinforcement Corroded, from 09 to 03 o'clock, within 8 inches: NO	008396_D_008397_SRC_8.9_8_A.jpg, PWC-2103892-01-AMH '008396'-AMH '008397'-MWL at 0.0 ft.JPG

Photo: 008396_D_008397_SRC_8.9_8_A.jpg, 00:00:51
 8.9FT, Surface Reinforcement Corroded, from 09 to 03 o'clock, within 8 inches: NO

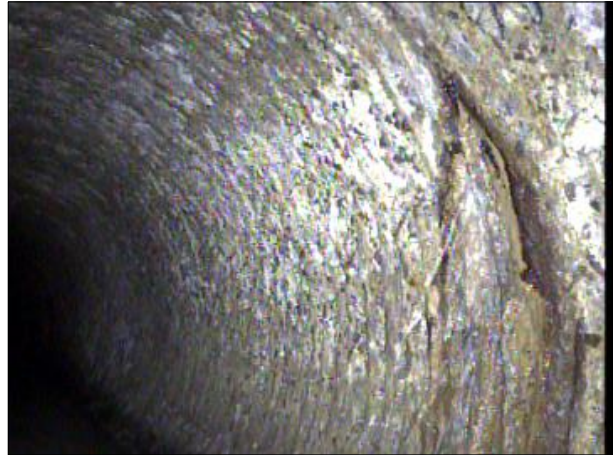
161.50	Infiltration Runner, from 02 to 03 o'clock, within 8 inches: NO	008396_D_008397_IR_161.5_9_A.jpg, PWC-2103892-01-AMH '008396'-AMH '008397'-MWL at 0.0 ft.JPG

Photo: 008396_D_008397_IR_161.5_9_A.jpg, 00:06:41
161.5FT, Infiltration Runner, from 02 to 03 o'clock, within 8 inches: NO

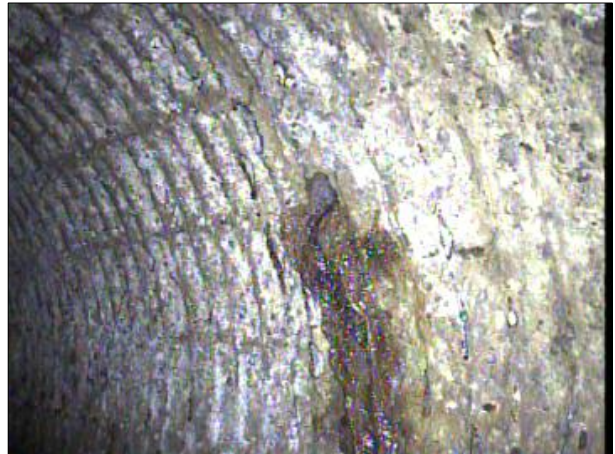
185.90	Infiltration Stain, from 03 to 04 o'clock, within 8 inches: NO	008396_D_008397_IS_185.9_10_A.jpg, PWC-2103892-01-AMH '008396'-AMH '008397'-MWL at 0.0 ft.JPG

Photo: 008396_D_008397_IS_185.9_10_A.jpg, 00:08:21
185.9FT, Infiltration Stain, from 03 to 04 o'clock, within 8 inches: NO

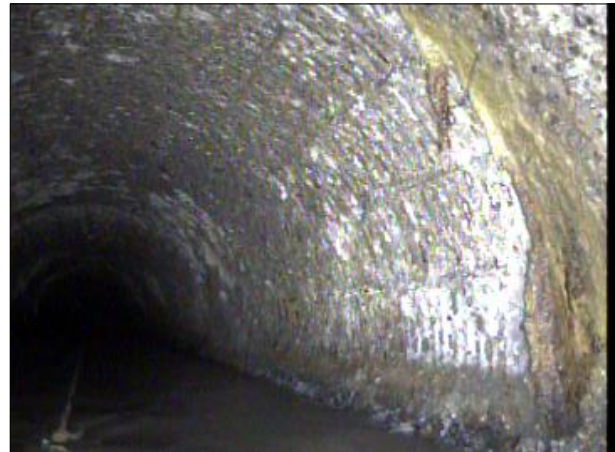
245.40	Infiltration Stain, from 02 to 04 o'clock, within 8 inches: NO	008396_D_008397_IS_245.4_11_A.jpg, PWC-2103892-01-AMH '008396'-AMH '008397'-MWL at 0.0 ft.JPG

Photo: 008396_D_008397_IS_245.4_11_A.jpg, 00:10:37
 245.4FT, Infiltration Stain, from 02 to 04 o'clock, within 8 inches: NO

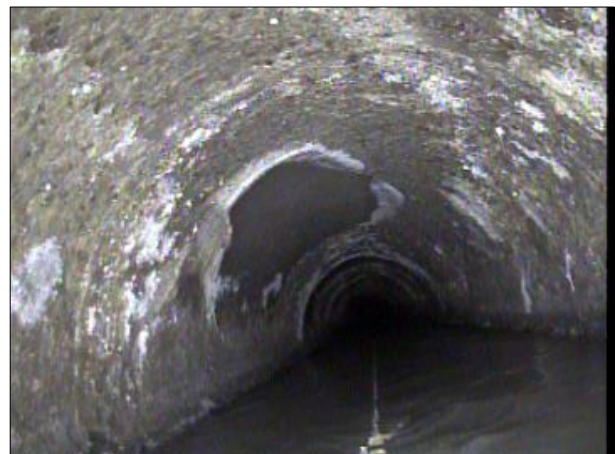
364.50	F1 Surface Reinforcement Corroded, from 09 to 03 o'clock, within 8 inches: NO	008396_D_008397_SRC_364.5_12_A.jpg, PWC-2103892-01-AMH '008396'-AMH '008397'-MWL at 0.0 ft.JPG

Photo: 008396_D_008397_SRC_364.5_12_A.jpg, 00:17:29
 364.5FT, Surface Reinforcement Corroded, from 09 to 03 o'clock, within 8 inches: NO

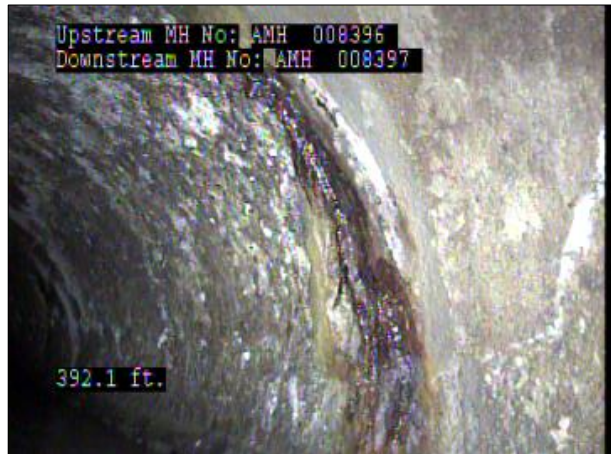
392.00	Infiltration Stain, from 01 to 04 o'clock, within 8 inches: NO	008396_D_008397_IS_392_14_A.jpg, PWC-2103892-01-AMH '008396'-AMH '008397'-IS at 392.0 ft.JPG

Photo: 008396_D_008397_IS_392_14_A.jpg, 00:20:09
 392FT, Infiltration Stain, from 01 to 04 o'clock, within 8 inches: NO

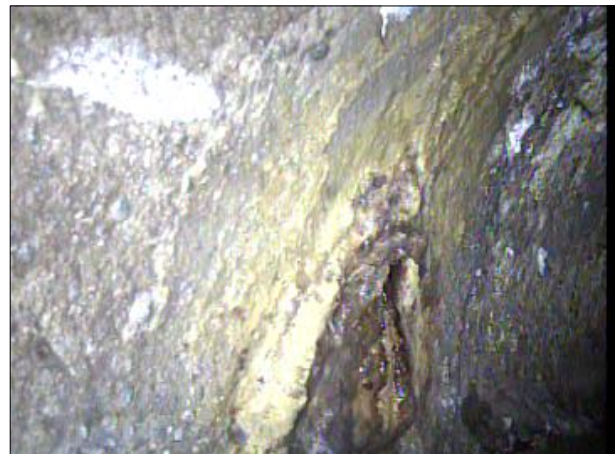
429.80	Infiltration Stain, at 08 o'clock, within 8 inches: NO	008396_D_008397_IS_429.8_15_A.jpg, PWC-2103892-01-AMH '008396'-AMH '008397'-MWL at 0.0 ft.JPG

Photo: 008396_D_008397_IS_429.8_15_A.jpg, 00:22:25
 429.8FT, Infiltration Stain, at 08 o'clock, within 8 inches: NO

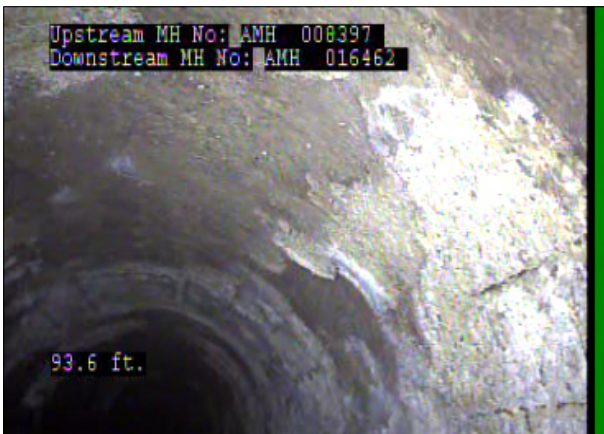
Photo: PWC-2103892-01-AMH '008397'-AMH '016462'-SAV at
 93.4 ft.JPG, 00:04:11
 93.4FT, Surface Aggregate Visible, from 08 to 04 o'clock,
 within 8 inches: NO

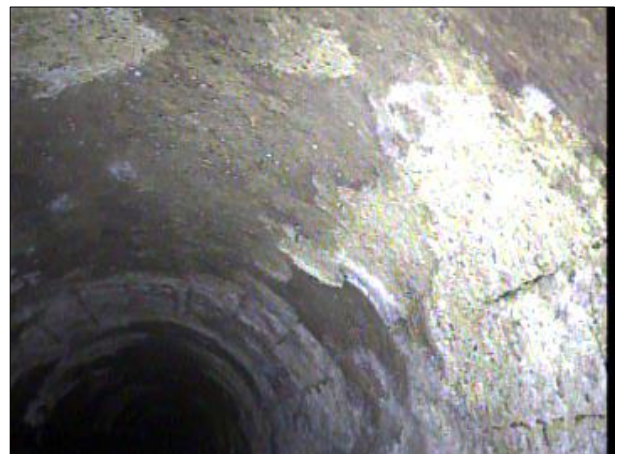
Photo: 008397_D_016462_SRC_93.5_25_A.jpg, 00:05:10
 93.5FT, Surface Reinforcement Corroded, from 08 to 04
 o'clock, within 8 inches: NO

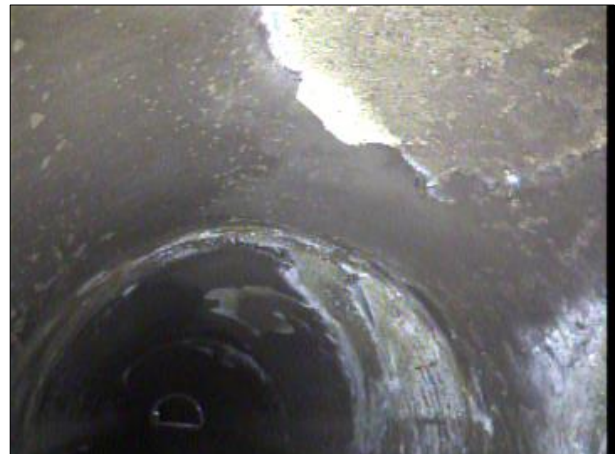
Photo: 008397_D_016462_SRC_302.1_29_A.jpg, 00:18:46
 302.1FT, Surface Reinforcement Corroded, from 08 to 04
 o'clock, within 8 inches: NO

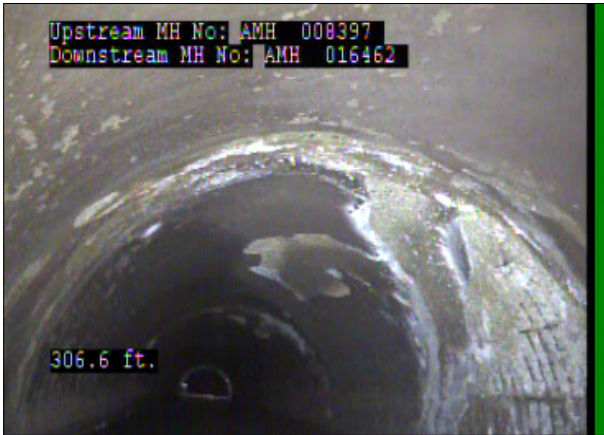
Photo: PWC-2103892-01-AMH '008397'-AMH '016462'-SRC at
 302.1 ft.JPG, 00:18:46
 302.1FT, Surface Reinforcement Corroded, from 08 to 04
 o'clock, within 8 inches: NO

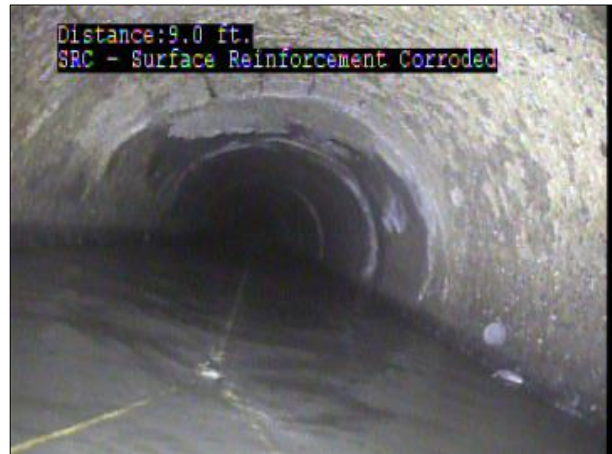
Photo: 016462_D_016461_SRC_9_33_A.jpg, 00:00:31
9FT, Surface Reinforcement Corroded, at 12 o'clock, within 8 inches: NO

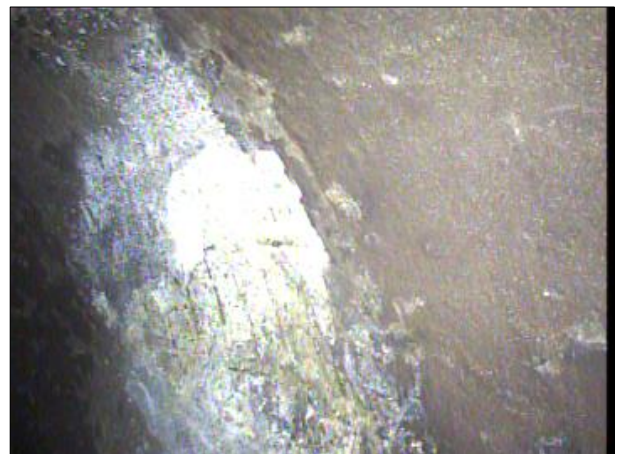
Photo: 016462_D_016461_SSS_246.8_35_A.jpg, 00:10:26
246.8FT, Surface Spalling, from 08 to 04 o'clock, within 8
inches: NO

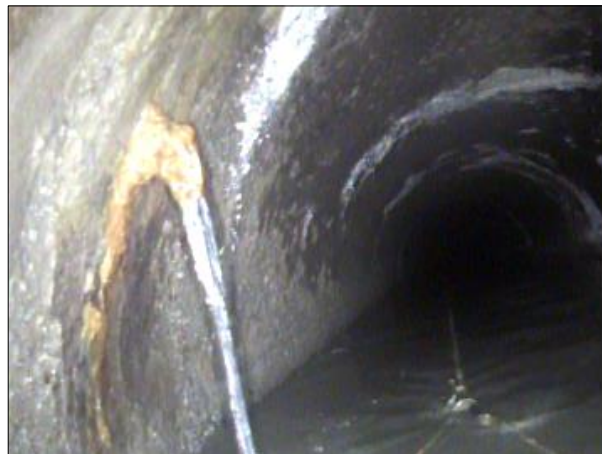
Photo: 016462_D_016461_IR_259.1_36_A.jpg, 00:11:50
 259.1FT, Infiltration Runner, at 09 o'clock, within 8 inches: NO

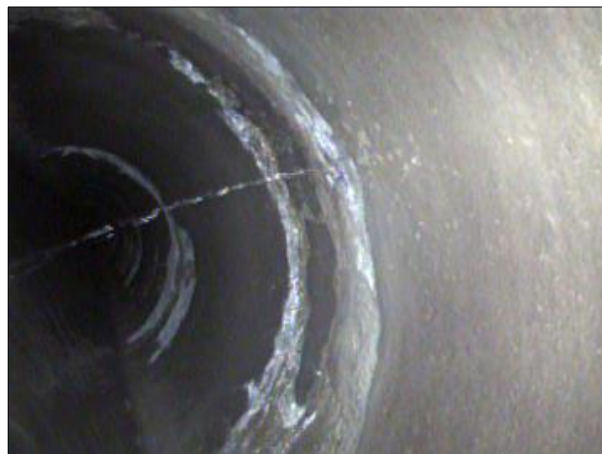
Photo: 016462_D_016461_IR_365.7_37_A.jpg, 00:18:26
 365.7FT, Infiltration Runner, at 12 o'clock, within 8 inches: NO

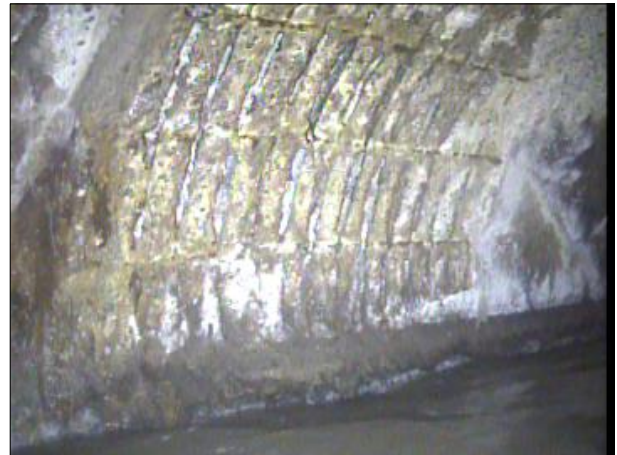
Photo: 016462_D_016461_SRC_508.4_40_A.jpg, 00:26:52
508.4FT, Surface Reinforcement Corroded, from 09 to 11 o'clock, within 8 inches: NO

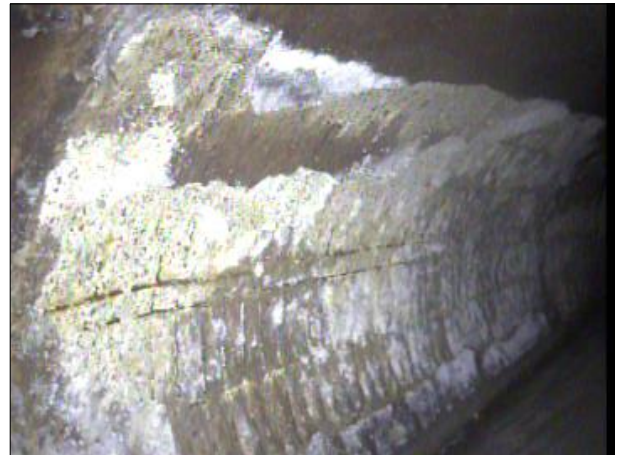
Photo: 016462_D_016461_SRC_544.8_42_A.jpg, 00:30:28
 544.8FT, Surface Reinforcement Corroded, from 08 to 11 o'clock, within 8 inches: NO

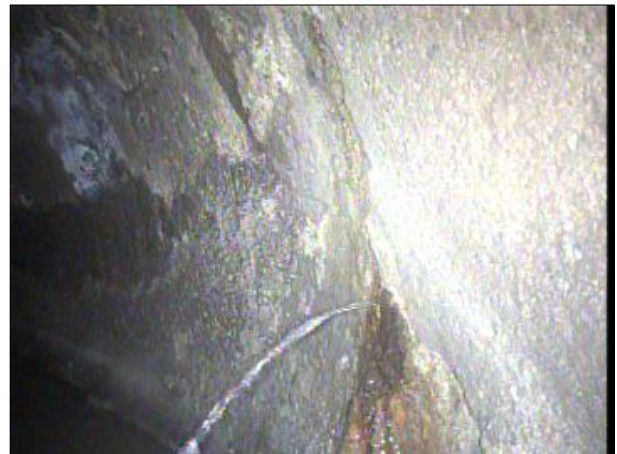
Photo: 016462_D_016461_IR_557.5_43_A.jpg, 00:31:52
 557.5FT, Infiltration Runner, at 03 o'clock, within 8 inches: NO

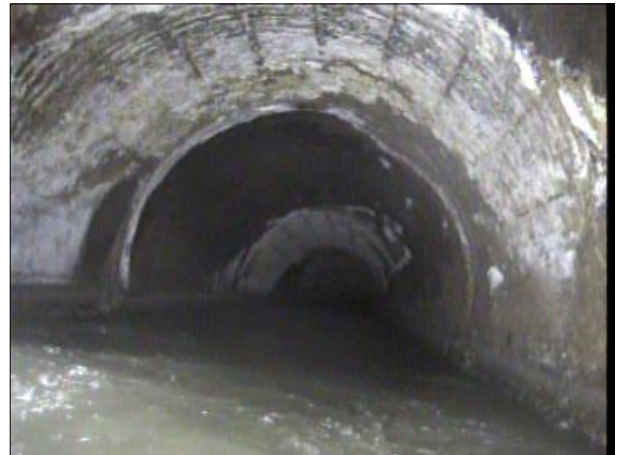
Photo: 016462_D_016461_SSS_789.7_48_A.jpg, 00:45:32
789.7FT, Surface Spalling, from 08 to 04 o'clock, within 8 inches: NO

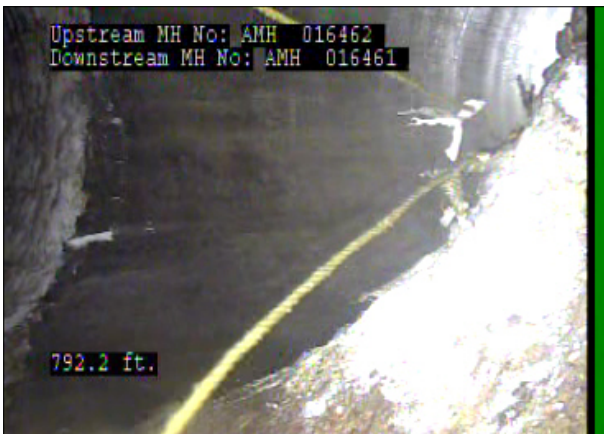
Photo: PWC-2103892-01-AMH '016462'-AMH '016461'-SSS at 789.7 ft.JPG, 00:45:32
789.7FT, Surface Spalling, from 08 to 04 o'clock, within 8 inches: NO

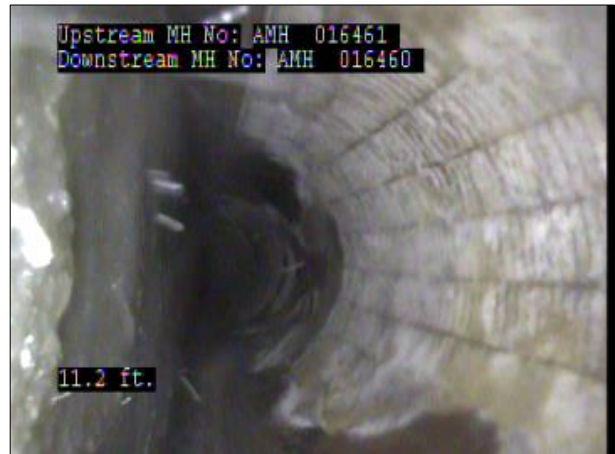
Photo: 016461_D_016460_SRC_11.2_53_A.jpg, 00:00:45
 11.2FT, Surface Reinforcement Corroded, from 09 to 03 o'clock, within 8 inches: NO

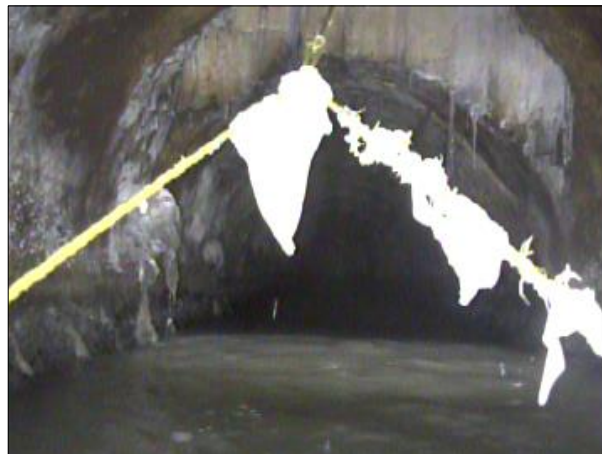
Photo: 016461_D_016460_SRC_563.4_56_A.jpg, 00:27:26
 563.4FT, Surface Reinforcement Corroded, from 09 to 03 o'clock, within 8 inches: NO

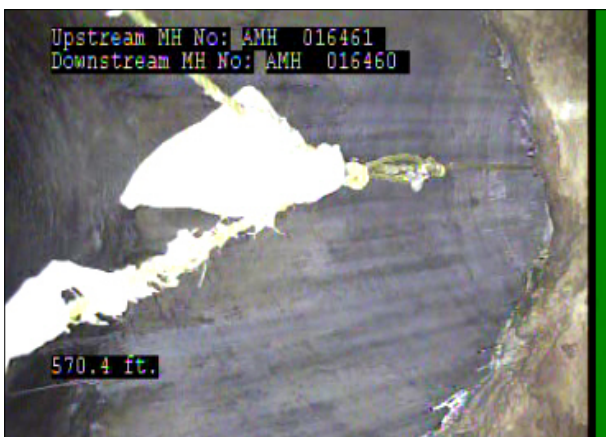
Photo: PWC-2103892-01-AMH '016461'-AMH '016460'-SRC at 563.4 ft.JPG, 00:27:26
 563.4FT, Surface Reinforcement Corroded, from 09 to 03 o'clock, within 8 inches: NO

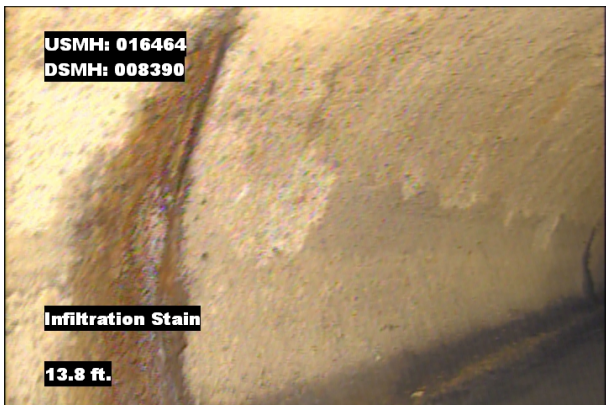
Photo: 016464_D_008390_IS_13.8.jpg, VCR No.: 1
 13.8FT, Infiltration Stain, from 08 to 10 o'clock, within 8 inches: YES

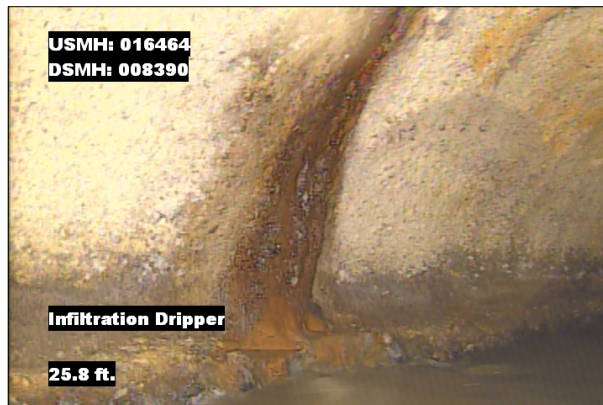
Photo: 016464_D_008390_ID_25.8.jpg, VCR No.: 1
 25.8FT, Infiltration Dripper, from 09 to 11 o'clock, within 8 inches: YES

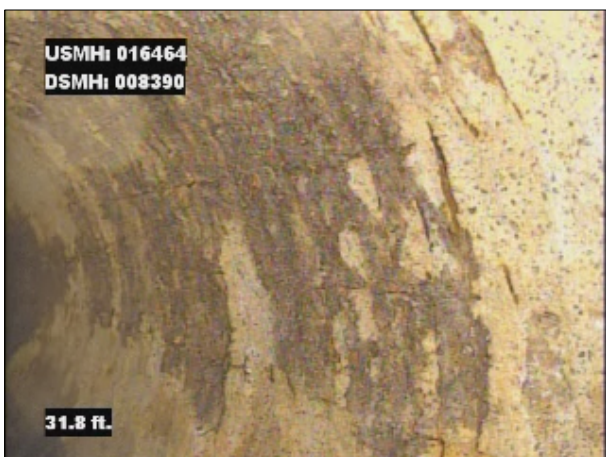
Photo: 016464_D_008390_SRV_31.jpg, VCR No.: 1
 31FT, Surface Reinforcement Visible, from 08 to 04 o'clock, within 8 inches of joint: NO, Start

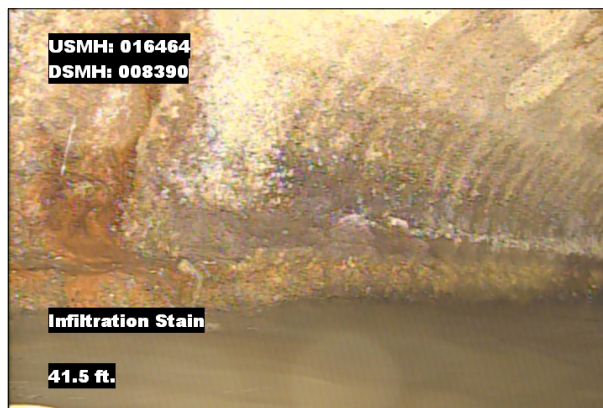
Photo: 016464_D_008390_IS_41.5.jpg, VCR No.: 1
 41.5FT, Infiltration Stain, from 09 to 11 o'clock, within 8 inches: YES

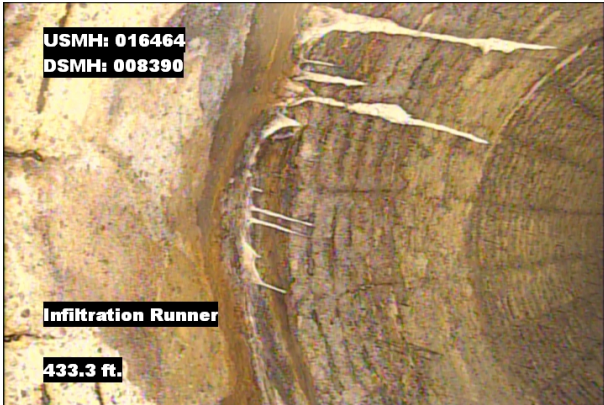
Photo: 016464_D_008390_IR_433.3.jpg, VCR No.: 1
 433.3FT, Infiltration Runner, from 11 to 10 o'clock, within 8 inches: YES

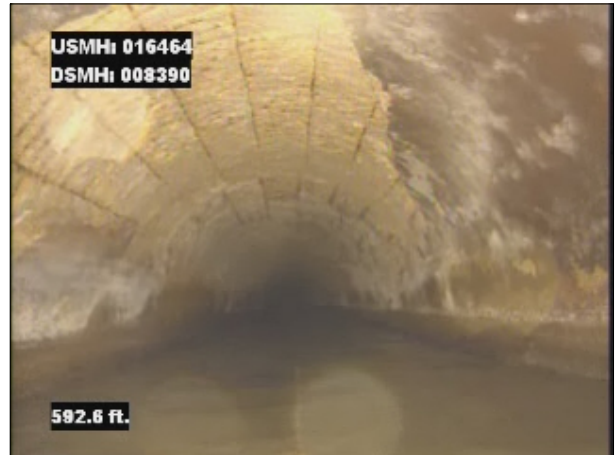
Photo: 016464_D_008390_SRV_592.jpg, VCR No.: 1
 592FT, Surface Reinforcement Visible, from 08 to 04 o'clock, within 8 inches of joint: NO, Start

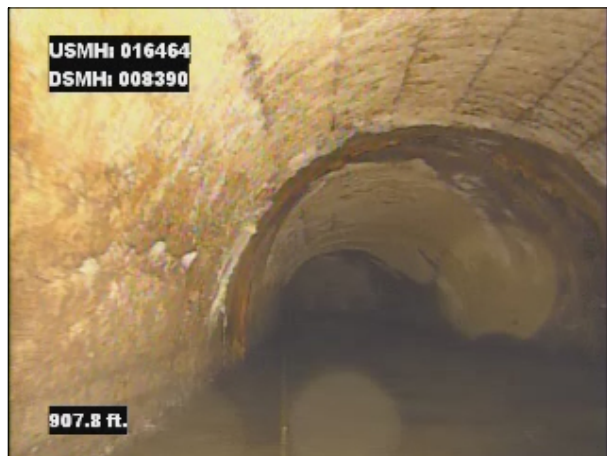
Photo: 016464_D_008390_IS_907.jpg, VCR No.: 1
 907FT, Infiltration Stain, from 08 to 04 o'clock, within 8 inches
 of joint: YES

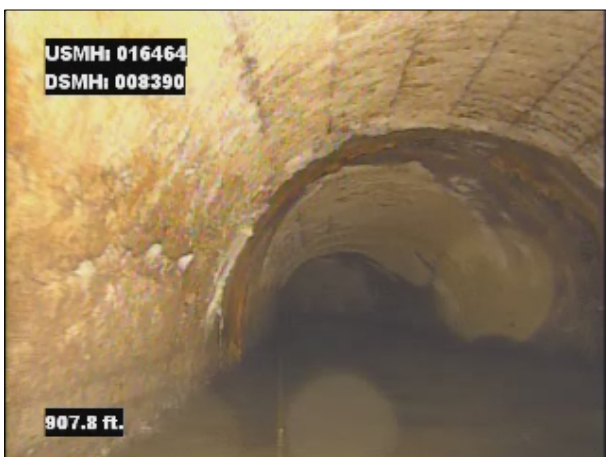
Photo: 016464_D_008390_SRV_908.jpg, VCR No.: 1
 908FT, Surface Reinforcement Visible, from 09 to 03 o'clock,
 within 8 inches of joint: YES

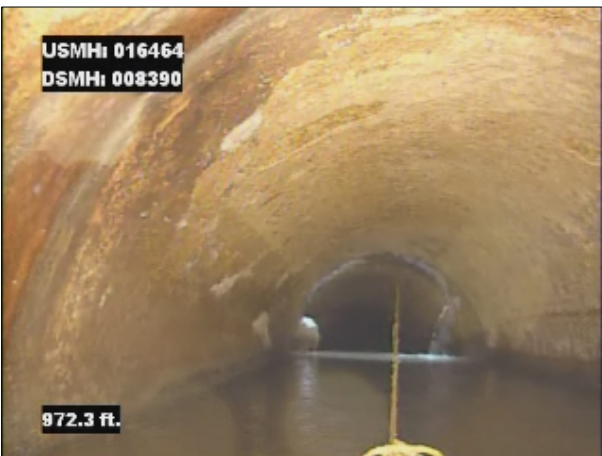
<u>972.00</u>	Infiltration Stain, from 08 to 04 o'clock, within 8 inches of joint: YES	016464_D_008390_IS_972.jpg				
	<u>981.00</u>	F4 Surface Aggregate Visible, from 07 to 05 o'clock, within 8 inches of joint: YES, Finish	016464_D_008390_SAV_981.jpg				
	<u>982.00</u>	F7 Surface Reinforcement Visible, from 08 to 04 o'clock, within 8 inches of joint: YES, Finish	016464_D_008390_SRV_982.jpg				
QSR	QMR	SPR	MPR	OPR	SPRI	MPRI	OPRI
5a3f	4131	1448	13	1461	3.93	2.6	3.92

Photo: 016464_D_008390_IS_972.jpg, VCR No.: 1
 972FT, Infiltration Stain, from 08 to 04 o'clock, within 8 inches of joint: YES

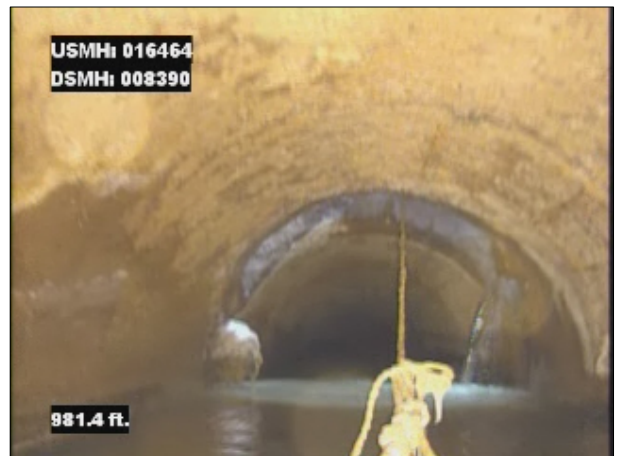
Photo: 016464_D_008390_SAV_981.jpg, VCR No.: 1
 981FT, Surface Aggregate Visible, from 07 to 05 o'clock, within 8 inches of joint: YES, Finish

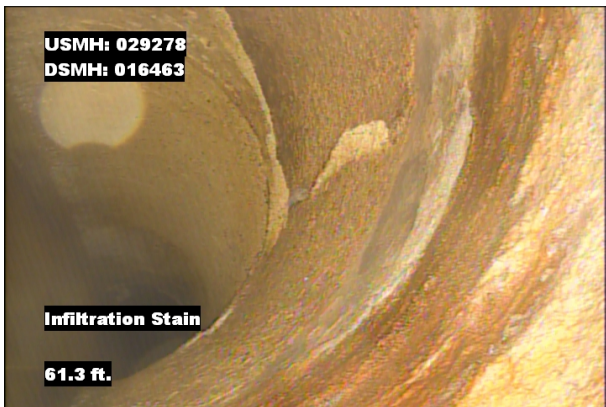
Photo: 029378_D_016463_IS_61.3.jpg, VCR No.: 1
 61.3FT, Infiltration Stain, from 08 to 04 o'clock, within 8 inches: NO

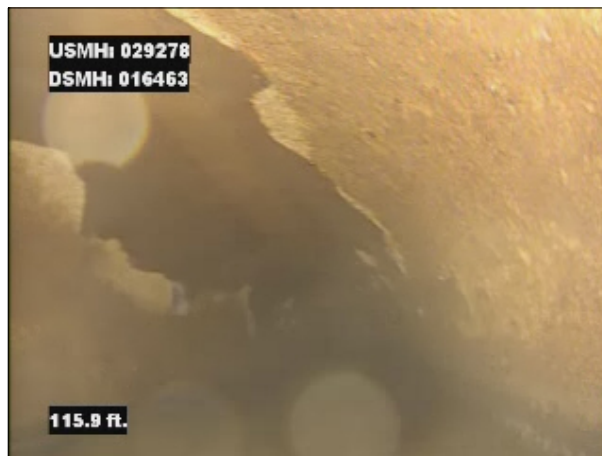
Photo: 029378_D_016463_SRV_115.jpg, VCR No.: 1
 115FT, Surface Reinforcement Visible, from 08 to 04 o'clock, within 8 inches of joint: NO, Finish
