## FAYETTEVILLE PUBLIC WORKS COMMISSION

**Bid Title:** FY26 Water Tank Maintenance Projects

**Addendum Date:** March 31, 2026

**WATER STORAGE TANK ANNUAL INSPECTION REPORT – EXTERIOR & INTERIOR DRY**

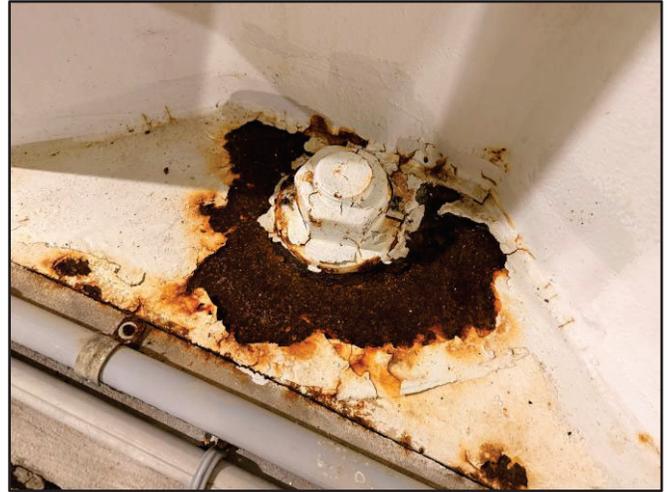
Structural					
Item	Condition				Notes
<b>Anchor bolts:</b>	<input type="checkbox"/> Good	<input type="checkbox"/> Fair	<input checked="" type="checkbox"/> Poor	<input type="checkbox"/> n/a	Significant corrosion at many anchor bolts at perimeter of skirt. <b>We recommend these be touched this fiscal year.</b>
<b>Concrete pedestals:</b>	<input checked="" type="checkbox"/> Good	<input type="checkbox"/> Fair	<input type="checkbox"/> Poor	<input type="checkbox"/> n/a	
<b>Legs:</b>	<input type="checkbox"/> Good	<input type="checkbox"/> Fair	<input type="checkbox"/> Poor	<input checked="" type="checkbox"/> n/a	
<b>Riser:</b>	<input checked="" type="checkbox"/> Good	<input type="checkbox"/> Fair	<input type="checkbox"/> Poor	<input type="checkbox"/> n/a	
<b>Sway rods:</b>	<input type="checkbox"/> Good	<input type="checkbox"/> Fair	<input type="checkbox"/> Poor	<input checked="" type="checkbox"/> n/a

**Photo 6**  
*Anchor bolt corrosion requiring repair.*

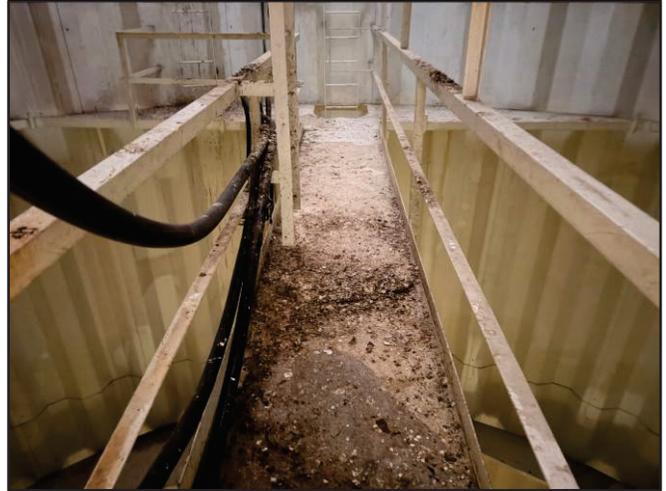
**Photo 8**  
*Catwalk – note significant debris from pigeons.*

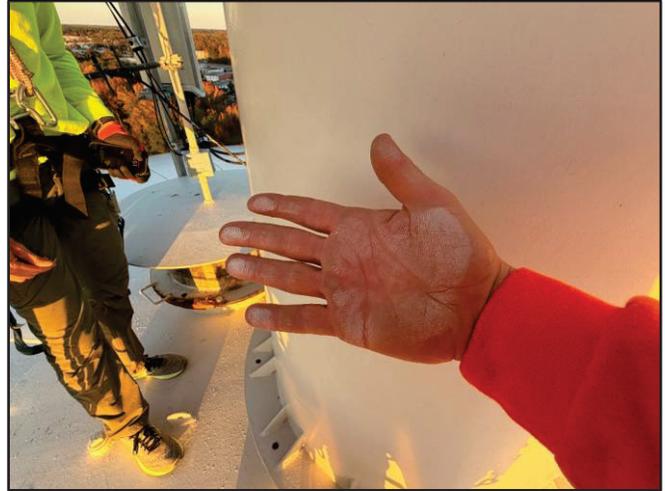
Coating				
Item				Notes
Type:	Potentially TNEMEC Series 72			See TNEMEC report dated 11/19/2018
Exterior condition:	<input checked="" type="checkbox"/> Good	<input type="checkbox"/> Fair	<input type="checkbox"/> Poor	<input type="checkbox"/> n/a
Interior condition:	<input type="checkbox"/> Good	<input checked="" type="checkbox"/> Fair	<input type="checkbox"/> Poor	<input type="checkbox"/> n/a
Last known re-coat:	2015±			Per TNEMEC records
Dry film thickness:	Exterior at ground		21.8mil	
	Interior dry		n/a	
	Exterior roof		16.5mil	
	Interior wet		n/a	
				<b>Result</b>
Testing:	ASTM D 3359 (tape test)		<input type="checkbox"/>	
	ASTM D 6677 (knife test)		<input type="checkbox"/>	
	ASTM D 4752 (solvent rub)		<input type="checkbox"/>	
	Field lead test		<input type="checkbox"/>	
<b>Interior wet notes:</b>				
N/a				
<b>Exterior &amp; interior dry notes:</b>				
Coating performing well overall. Interior appears to have been spot repaired. Some areas of inner coat delamination are present on interior of sidewalls – mainly near the climbing ladder. Isolated areas of corrosion at weld seams and at top of tank. Coating on stainless steel ladder is delaminating. Continue to perform annual inspections to assess coating condition. Consider scheduling for overcoat within the next 5 years.

**Photo 12**  
*Chalkiness / coating breakdown at top exterior.*

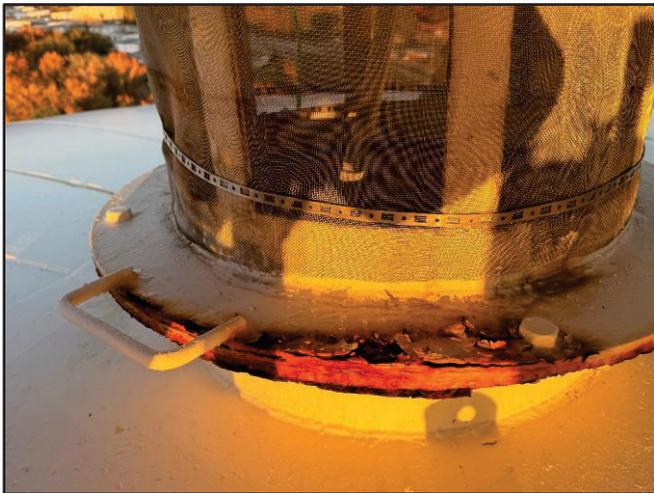
**Photo 13**  
*Top vent screen with corrosion at connection plate.*

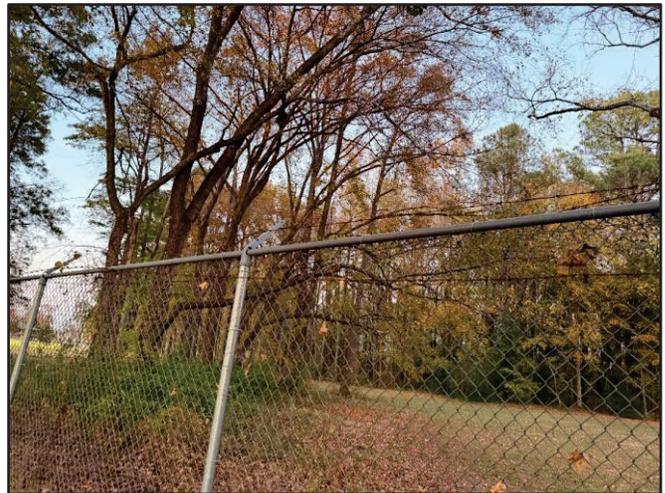
<b>Other notes:</b>				
Some locations of barbed wire broken which require repair.

**Photo 14**  
*Deteriorated barbed wire at north side of compound.*

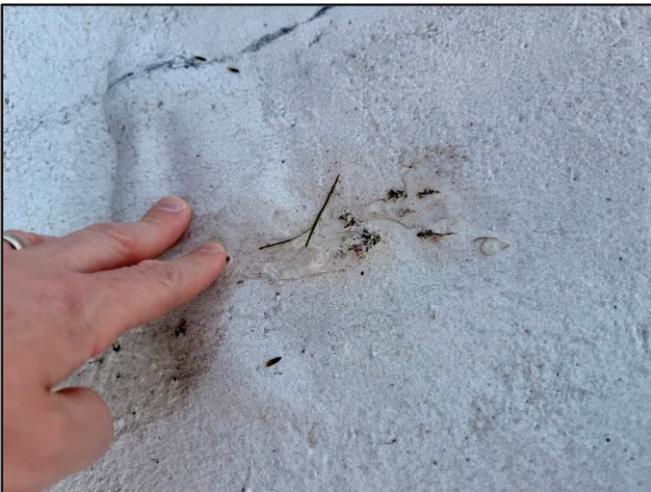
**Photo 4**  
*Blister at roof.*

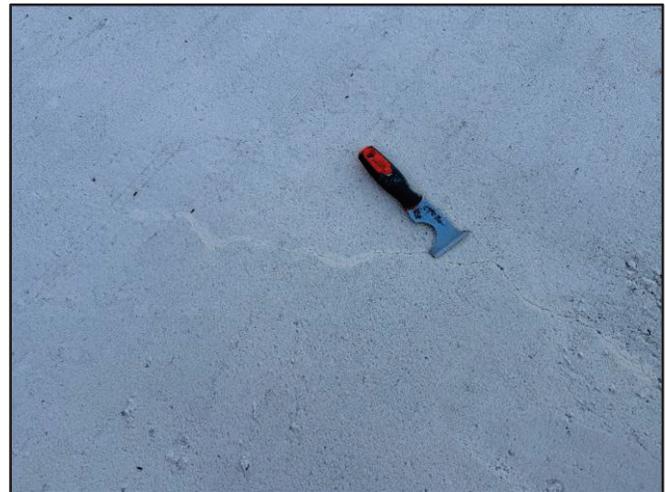
**Photo 5**  
*Break in coating at roof.*

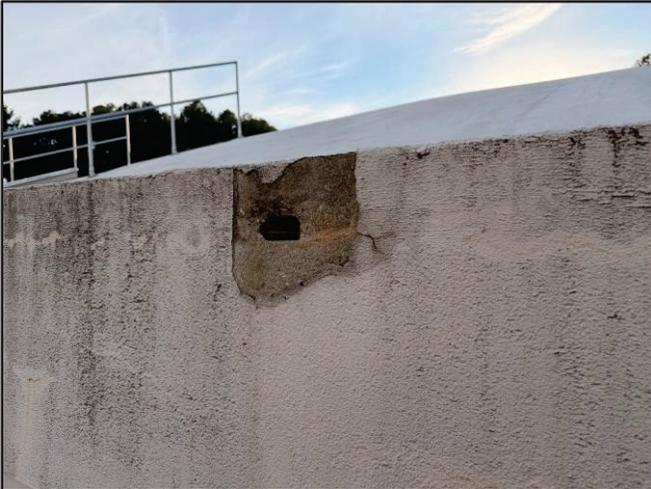
Structural					
Item	Condition				Notes
<b>Concrete shell:</b>	<input checked="" type="checkbox"/> Good	<input type="checkbox"/> Fair	<input type="checkbox"/> Poor	<input type="checkbox"/> n/a	See below
<b>Concrete base:</b>	<input type="checkbox"/> Good	<input type="checkbox"/> Fair	<input type="checkbox"/> Poor	<input checked="" type="checkbox"/> n/a	Not exposed to view.
<b>Concrete cap:</b>	<input checked="" type="checkbox"/> Good	<input type="checkbox"/> Fair	<input type="checkbox"/> Poor	<input type="checkbox"/> n/a	
<b>Ladder:</b>	<input checked="" type="checkbox"/> Good	<input type="checkbox"/> Fair	<input type="checkbox"/> Poor	<input type="checkbox"/> n/a	
<b>Other notes:</b>					
<p>Tank recoated in 2020. Exterior structure appears in good condition. Minor staining occurring at breaks in roof coating, potentially due to concrete outgassing. The breaks in the coating are presumably due to minor movement in the concrete roof structure below reading through the coating.</p> <p>One location of spalled concrete at top of sidewall, see photos. Appears to be a block of wood embedded in concrete from original construction. Recommend cementitious patching mortar repair to this area during FY26.</p>

**Photo 8**  
*Spalled concrete at northeast sidewall.*

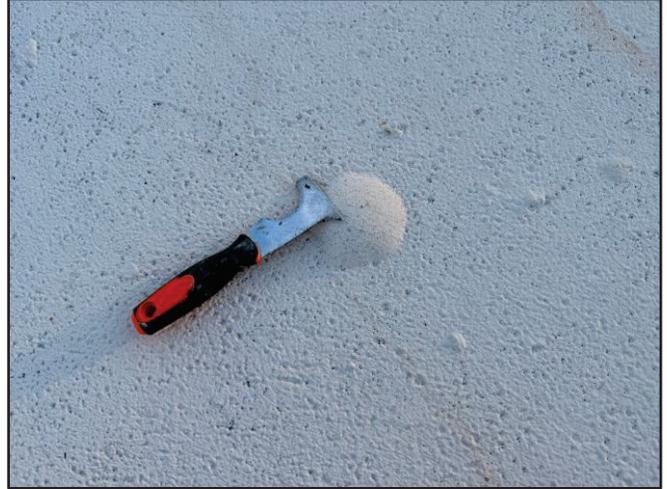
Coating performing adequately overall, although moderate sized blisters have developed in several locations on the tank roof and sidewalls. See photos. Blisters are becoming more widespread, particularly at top of tank. Some mildew growth is present on the sidewalls of the tank at the northwest face of the tank. No recommended coating action at present time.

**Photo 7**  
*Top of tank blister.*

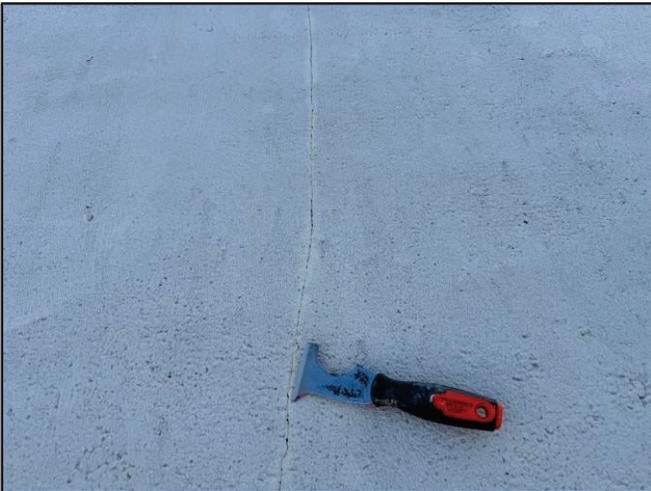
**Photo 8**  
*Crack in coating at top of tank.*

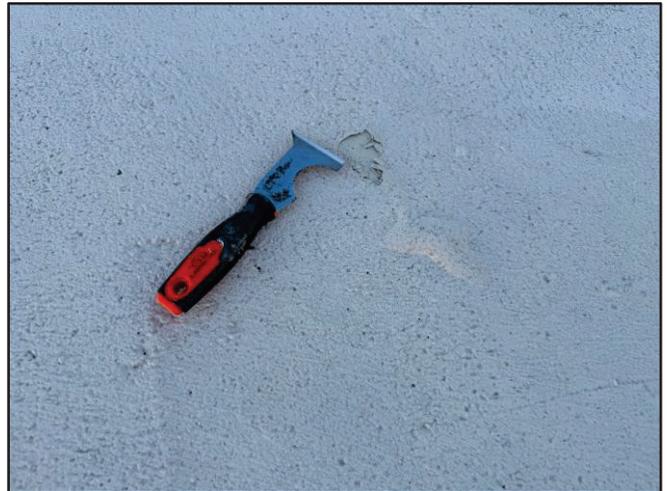
**Photo 9**  
*Break in coating at top of tank.*

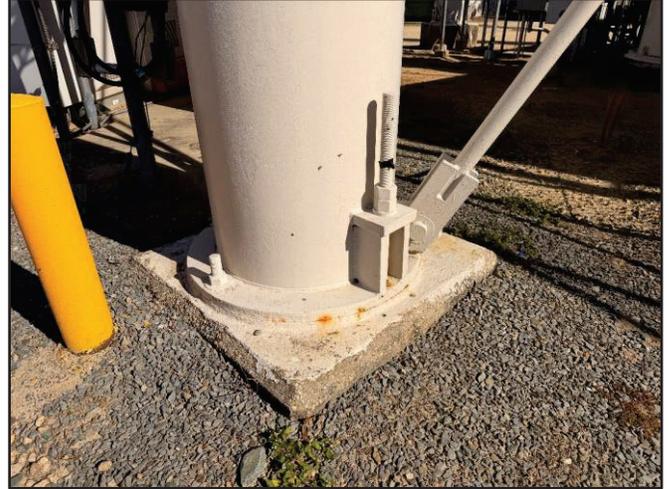
Item	Condition				Notes
<b>Anchor bolts:</b>	<input checked="" type="checkbox"/> Good	<input type="checkbox"/> Fair	<input type="checkbox"/> Poor	<input type="checkbox"/> n/a	Some corrosion beginning at bottom of baseplate interface with concrete pedestals.
<b>Concrete pedestals:</b>	<input checked="" type="checkbox"/> Good	<input type="checkbox"/> Fair	<input type="checkbox"/> Poor	<input type="checkbox"/> n/a	
<b>Legs:</b>	<input checked="" type="checkbox"/> Good	<input type="checkbox"/> Fair	<input type="checkbox"/> Poor	<input type="checkbox"/> n/a	
<b>Riser:</b>	<input checked="" type="checkbox"/> Good	<input type="checkbox"/> Fair	<input type="checkbox"/> Poor	<input type="checkbox"/> n/a	
<b>Sway rods:</b>	<input checked="" type="checkbox"/> Good	<input type="checkbox"/> Fair	<input type="checkbox"/> Poor	<input type="checkbox"/> n/a	
<b>Hub rods:</b>	<input checked="" type="checkbox"/> Good	<input type="checkbox"/> Fair	<input type="checkbox"/> Poor	<input type="checkbox"/> n/a

**Photo 4**  
*Concrete pedestal and column base. Corrosion present at bottom of base plate.*

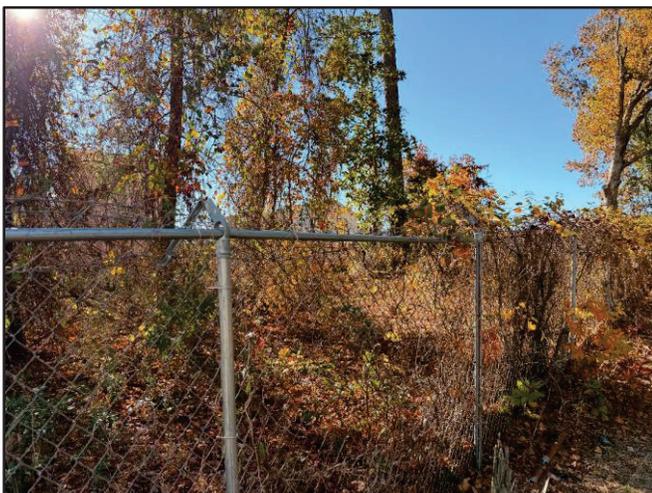
**Photo 5**  
*Vegetation overgrowth at compound perimeter.*

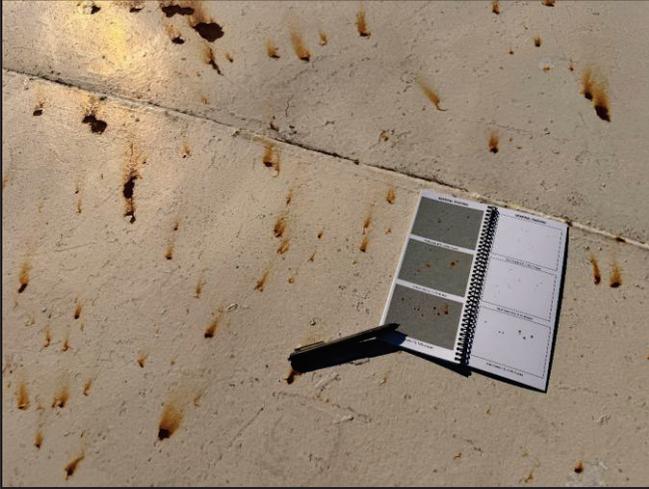
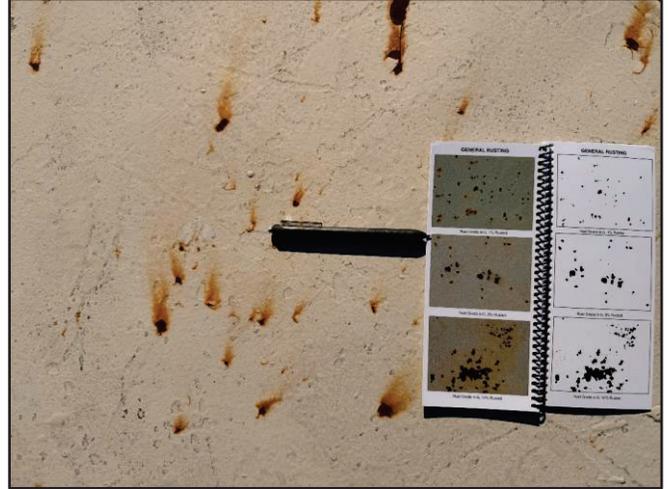
<b>Antenna corral:</b>	<input checked="" type="checkbox"/> Good	<input type="checkbox"/> Fair	<input type="checkbox"/> Poor	<input type="checkbox"/> n/a	
<b>Other notes:</b>					
Tank exterior in fair condition overall. Top of tank shell inside of antenna corral is in poor condition. Moderate corrosion on horizontal surfaces. Moderate to heavy mildew buildup on north and east sides of tank bowl and catwalk. See coating section for additional comments.

*General rusting on top of tank bowl inside of corral.*

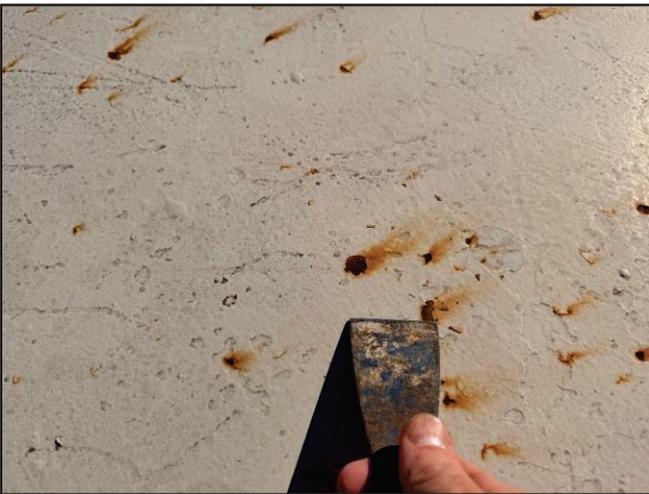
*General rusting on top of tank bowl, zoomed in.*

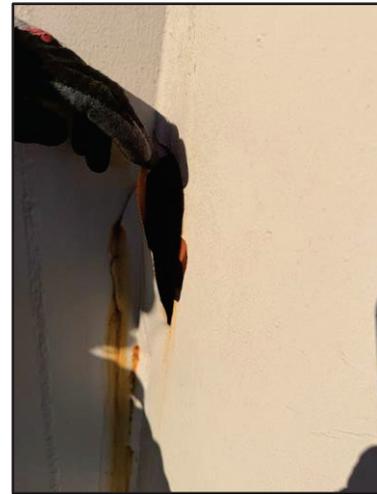
*General rusting on tank side bowl.*

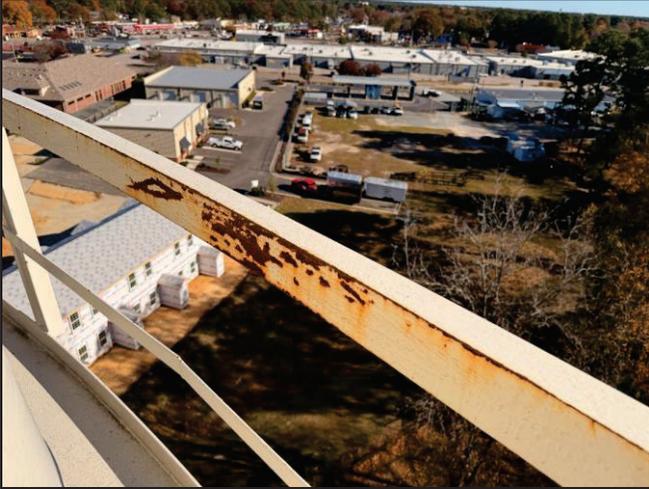
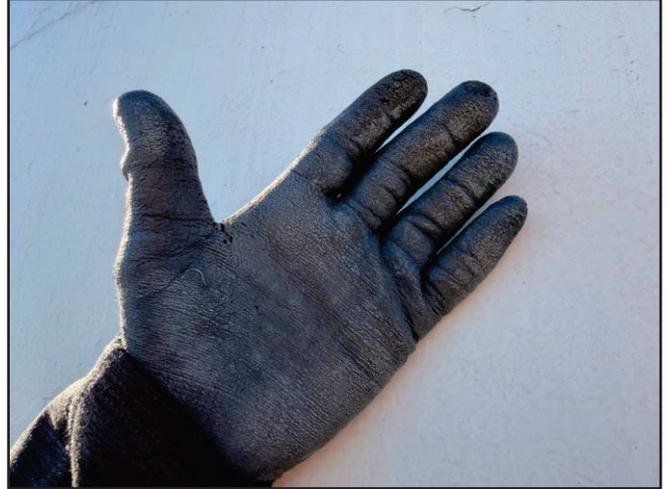
**Photo 11**  
*Corrosion at catwalk handrail.*

**Photo 12**  
*Corrosion at catwalk handrail.*

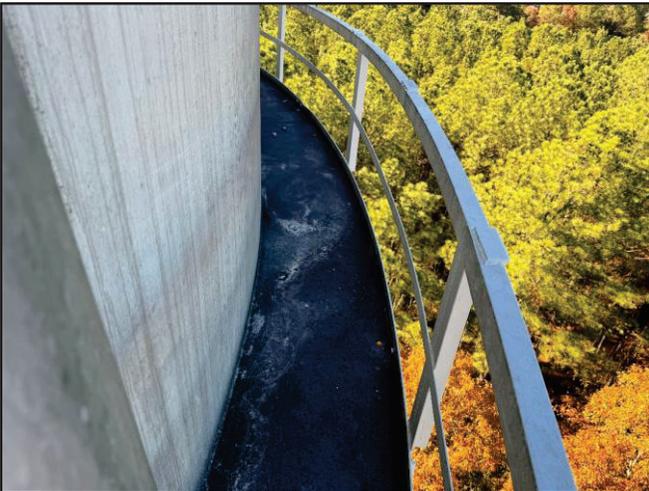
**Photo 13**  
*Mildew accumulation at east and north side of catwalk.*

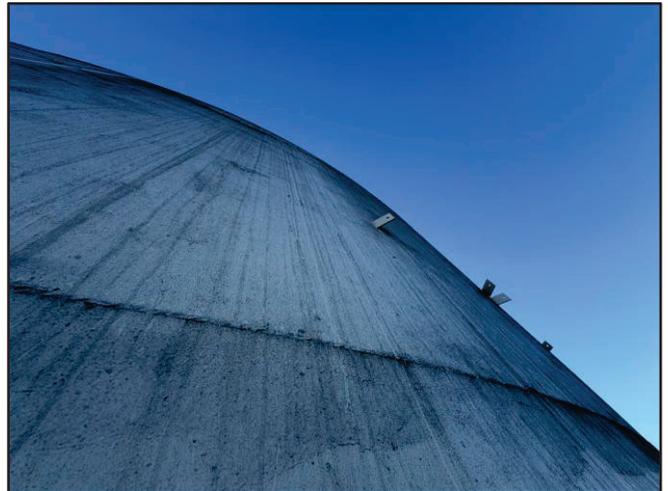
**Photo 14**  
*Mildew buildup at tank side wall.*

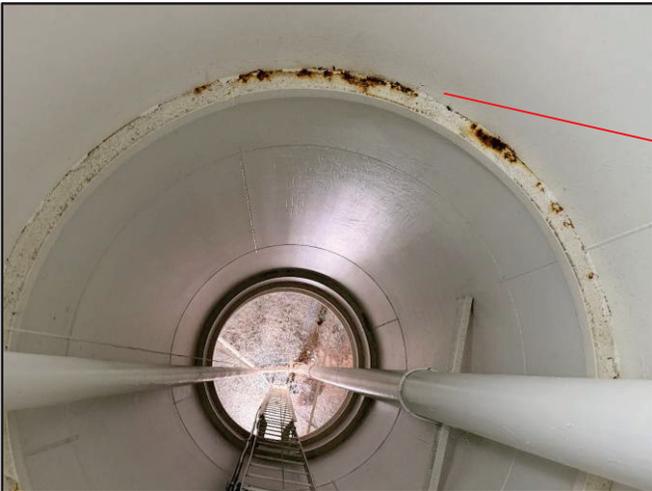
*Corrosion at stiffeners.*

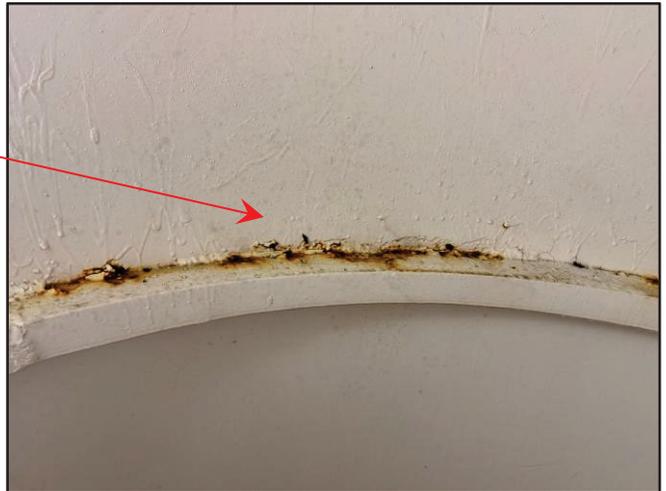
*Zoomed in at corrosion.*

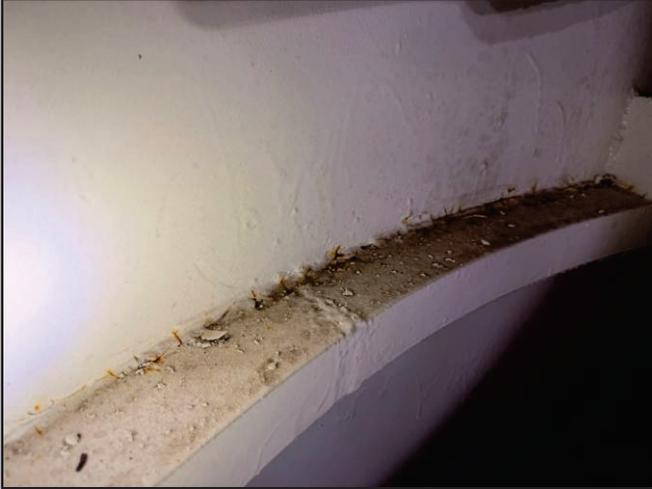
*Corrosion & cracking of coating at stiffener.*

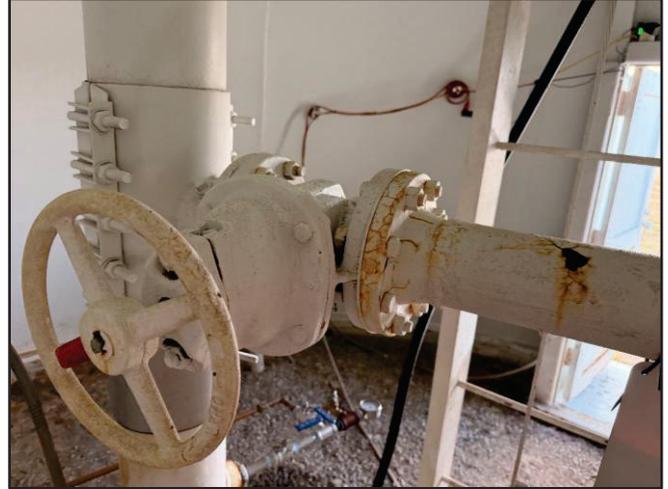
*Corrosion on pump equipment.*

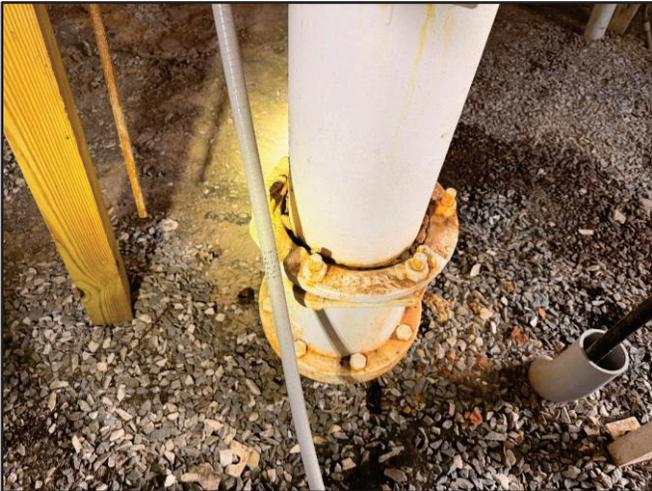
*Pinpoint corrosion on riser tube.*

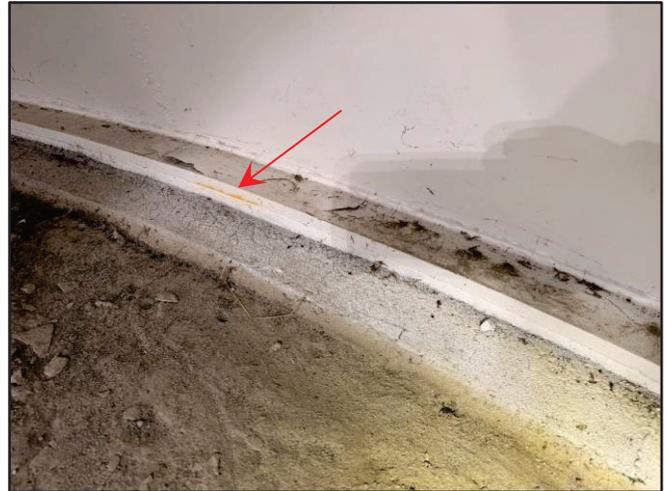
*Base of tank viewed from interior. Minor corrosion encountered and cracking/delamination of coating.*

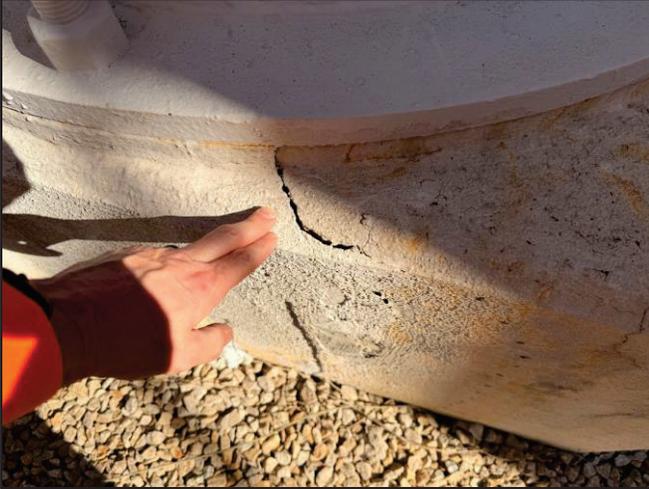
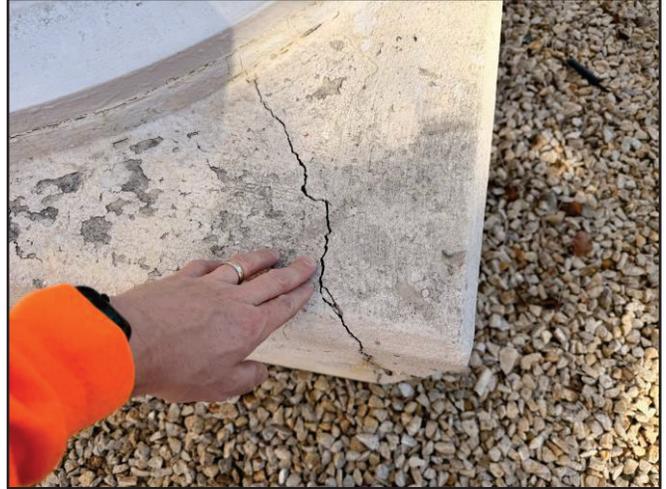
*Cracks / spalling at concrete pedestal.*

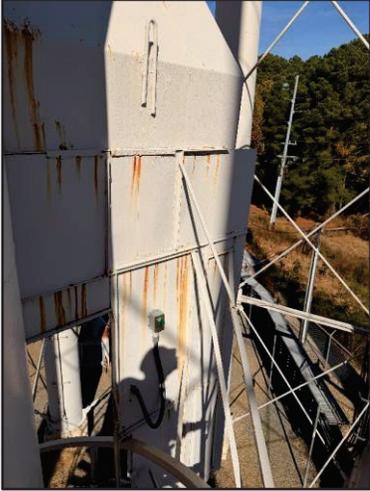
*Safety gate with moderate corrosion and staining.*

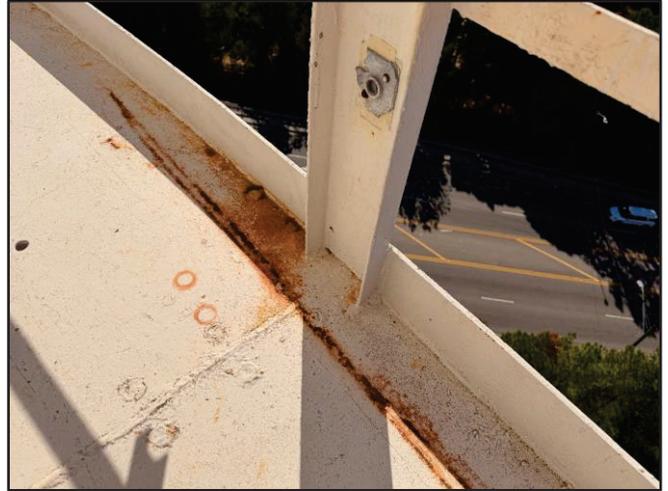
Moderate to heavy chalkiness observed, particularly at shell sidewalls. Some isolated corrosion throughout various elements including most prominently at the catwalk (pinpoint rusting typically estimated as type 4-P, and in some isolated areas more significant), at the tank legs, tank bowl, and the riser stairs at isolated areas. The crown of the tank was overcoated during removal of the interior corral in the summer of 2022. **Due to several factors, including: 1) the high traffic roads adjacent to the tank and preference for containment, 2) lifecycle costs of an overcoat vs. blasting, and 3) the telecommunications equipment on the tank, we recommend not performing an overcoat but rather budget for blasting and installing a new high-performance coating in the next 3 years.** Coating rehabilitation should occur before corrosion begins to result in pitting or deterioration of structural elements – particularly ladders used to access the tank by maintenance personnel. In the meantime, PWC should continue to perform annual inspections to assess coating condition.

*Corrosion at catwalk.*

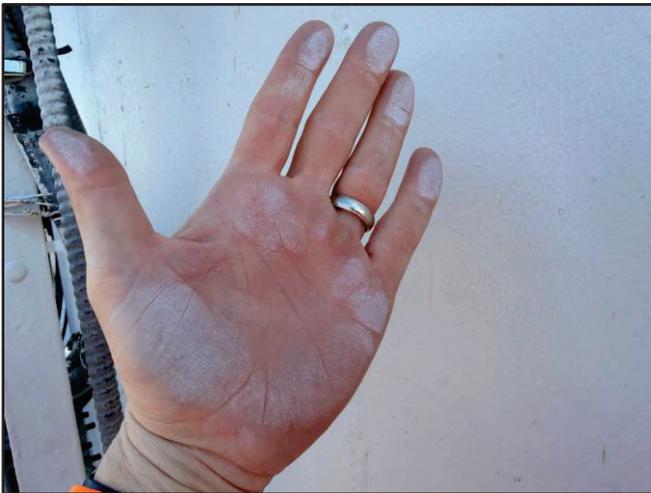
*Chalkiness of coating at tank sidewall.*

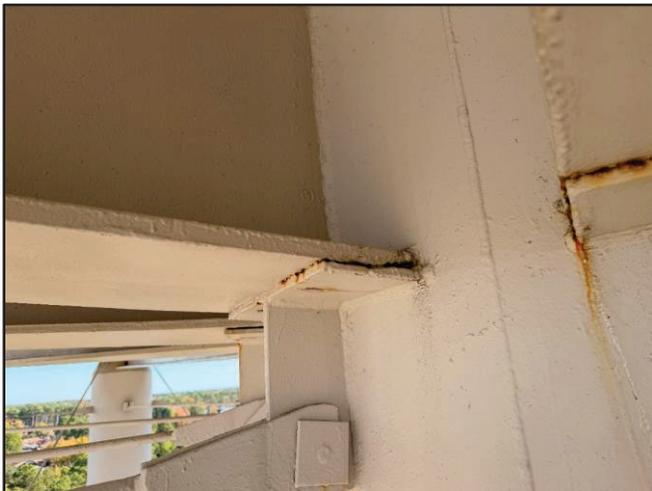
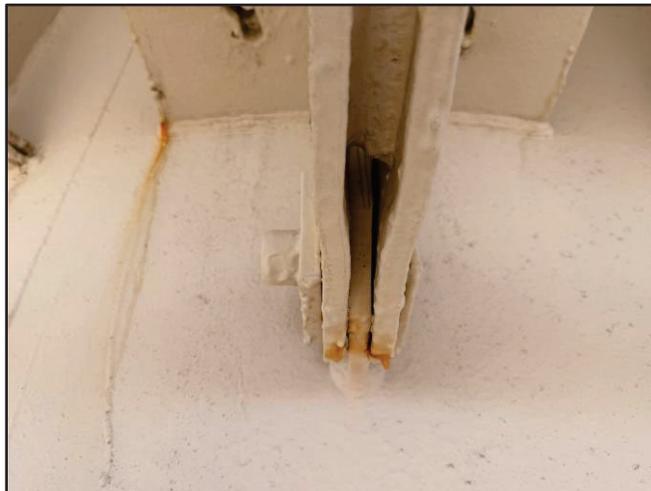
<b>Hub rods:</b>	<input type="checkbox"/> Good	<input checked="" type="checkbox"/> Fair	<input type="checkbox"/> Poor	<input type="checkbox"/> n/a	Minor to moderate corrosion at faying surfaces throughout exterior of tank.
<b>Steel shell:</b>	<input type="checkbox"/> Good	<input checked="" type="checkbox"/> Fair	<input type="checkbox"/> Poor	<input type="checkbox"/> n/a	Spot corrosion at damaged surfaces. Some delamination of coating at underside of steel ribs. Moderate chalking throughout.
<b>Ladder:</b>	<input checked="" type="checkbox"/> Good	<input type="checkbox"/> Fair	<input type="checkbox"/> Poor	<input type="checkbox"/> n/a	
<b>Antenna corral:</b>	<input checked="" type="checkbox"/> Good	<input type="checkbox"/> Fair	<input type="checkbox"/> Poor	<input type="checkbox"/> n/a	
<b>Other notes:</b>

**Photo 11**  
*Corrosion at faying surfaces.*

**Photo 12**  
*Corrosion at faying surfaces.*
