TO: All Prospective Bidders
FROM: Tanya Hazlett, Procurement Advisor (774)
SUBJECT: **ADDENDUM NO. 3 – PWC2223039 RFQ/DESIGN/BUILD SERVICES
LINE 54 INCH OUTFALL RESEARCH TO I-95**

**Response to Questions
Request for Statement of Qualifications
Design-Build Services Line 54-Inch Outfall Research Drive to I-95**

**54" OUTFALL REHABILITATION
 MANHOLE APPROXIMATE SURVEY DATA**
 FIGURE 1

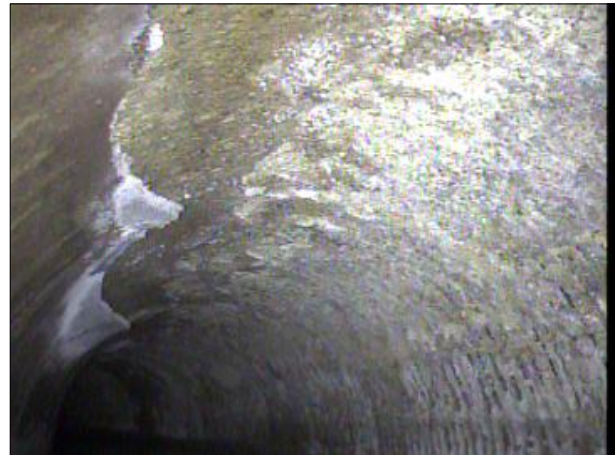
Photo: PWC-2103892-01-AMH '008397'-AMH '016462'-LL at
 246.7 ft.JPG, 00:15:08
 246.7FT, Alignment Left, 25°

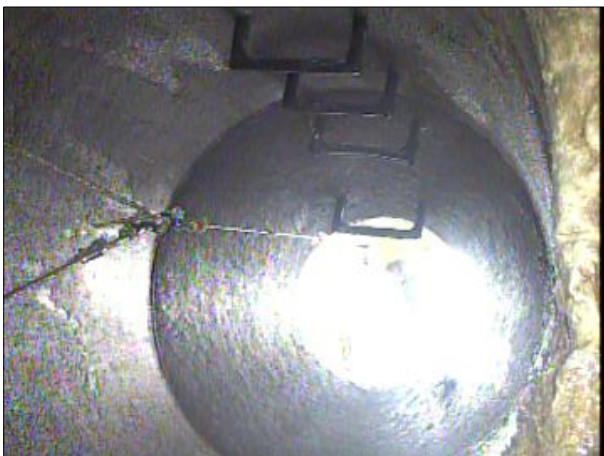
Photo: PWC-2103892-01-AMH '008397'-AMH '016462'-AMH at 374.3 ft.JPG, 00:23:35
374.3FT, Manhole

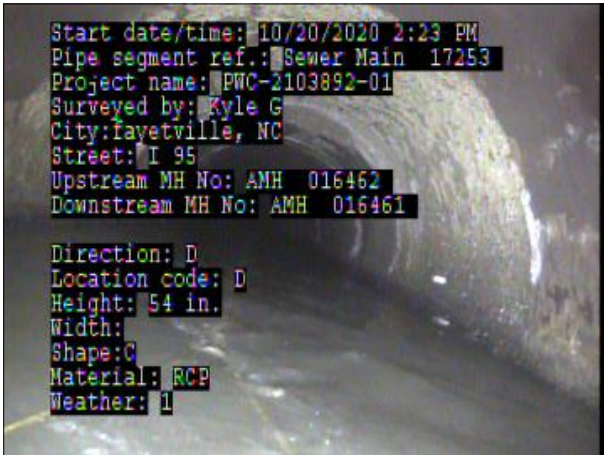
Photo: PWC-2103892-01-AMH '016462'-AMH '016461'-AMH at 0.0 ft.JPG
OFT, Manhole

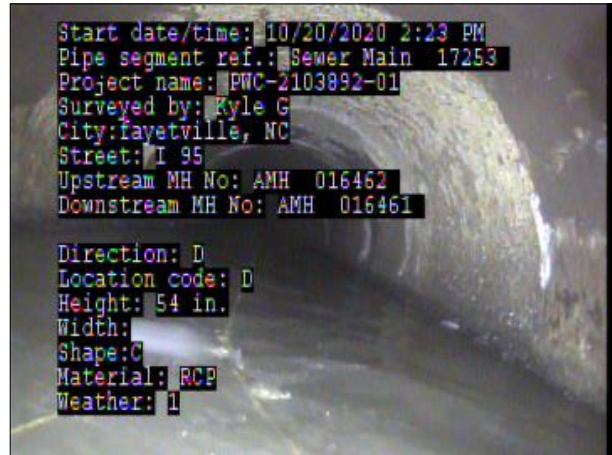
Photo: PWC-2103892-01-AMH '016462'-AMH '016461'-MWL at 0.0 ft.JPG
OFT, Water Level, 35% of cross sectional area

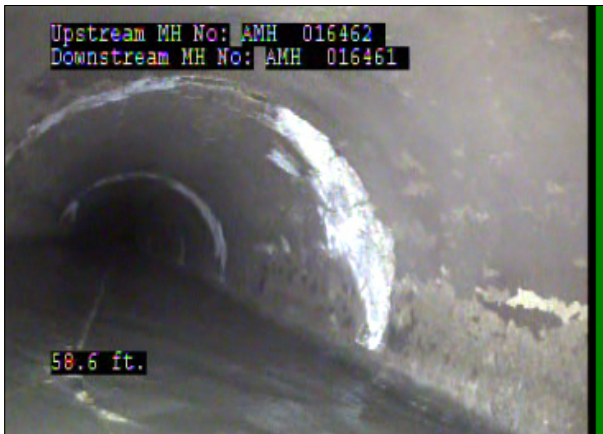
Photo: 016462_D_016461_MGP_58.4_34_A.jpg, 00:02:39
58.4FT, General Photograph

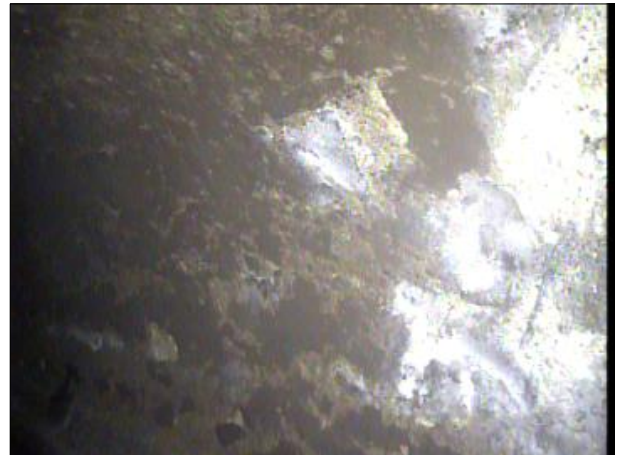
Photo: PWC-2103892-01-AMH '016462'-AMH '016461'-MGP at
58.4 ft.JPG, 00:02:39
58.4FT, General Photograph

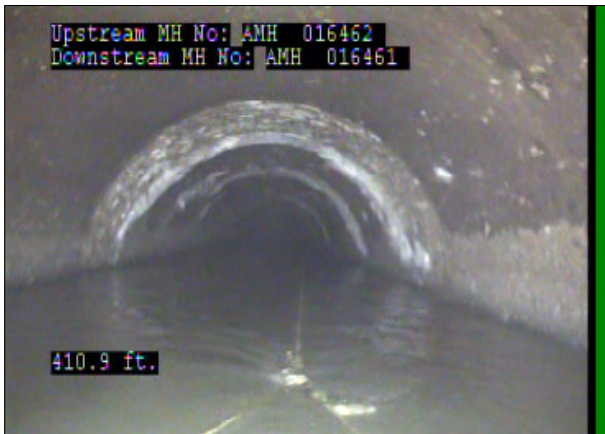
Photo: 016462_D_016461_SRI_410.2_38_A.jpg, 00:20:37
 410.2FT, Surface Roughness Increased, from 08 to 04
 o'clock, within 8 inches: NO

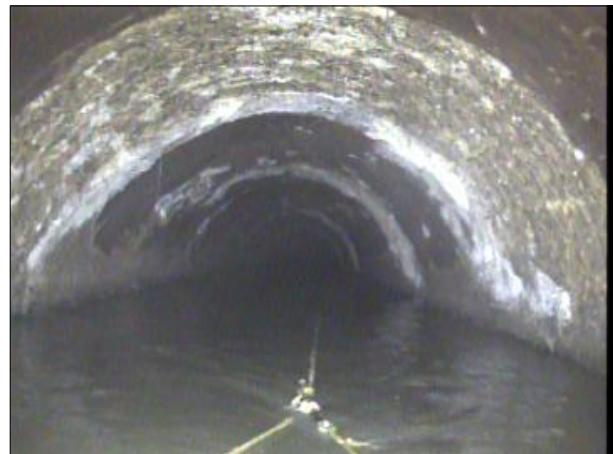
Photo: PWC-2103892-01-AMH '016462'-AMH '016461'-SRI at
 410.2 ft.JPG, 00:20:37
 410.2FT, Surface Roughness Increased, from 08 to 04
 o'clock, within 8 inches: NO

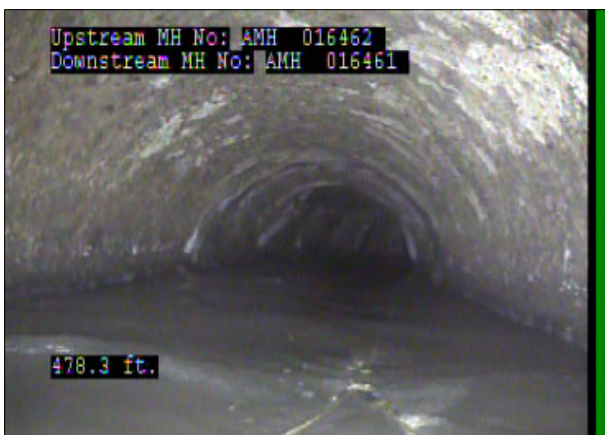
Photo: 016462_D_016461_LR_478.3_39_A.jpg, 00:24:03
 478.3FT, Alignment Right, 25°

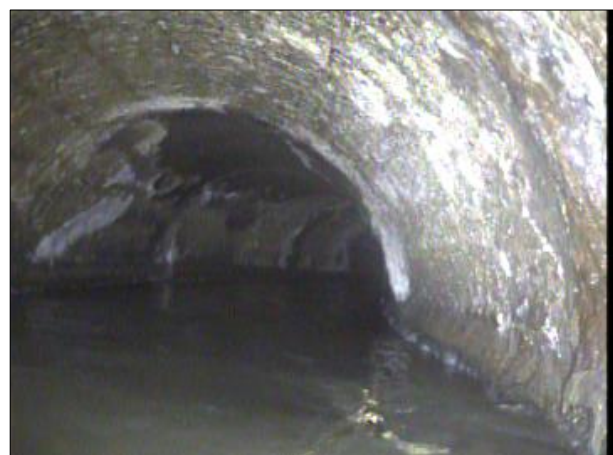
Photo: PWC-2103892-01-AMH '016462'-AMH '016461'-LR at
 478.3 ft.JPG, 00:24:03
 478.3FT, Alignment Right, 25°

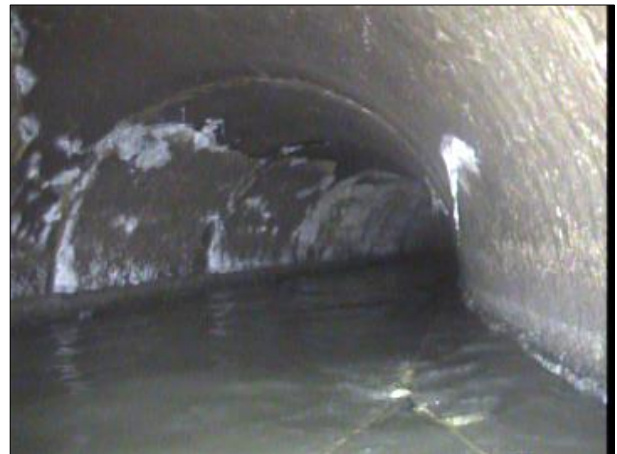
Photo: PWC-2103892-01-AMH '016462'-AMH '016461'-LR at 521.0 ft.JPG, 00:27:37
521FT, Alignment Right, 25°

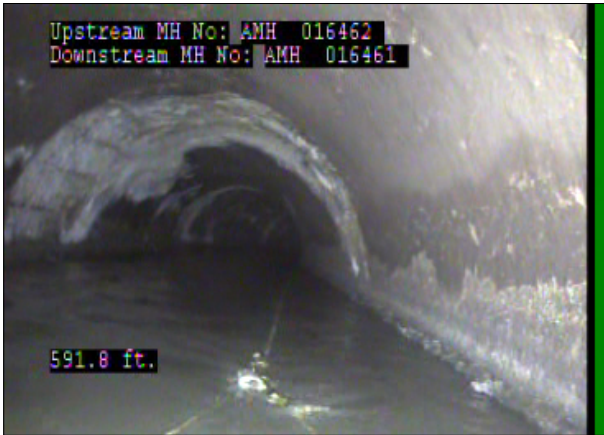
Photo: 016462_D_016461_LR_591.8_44_A.jpg, 00:33:50
 591.8FT, Alignment Right, 20°

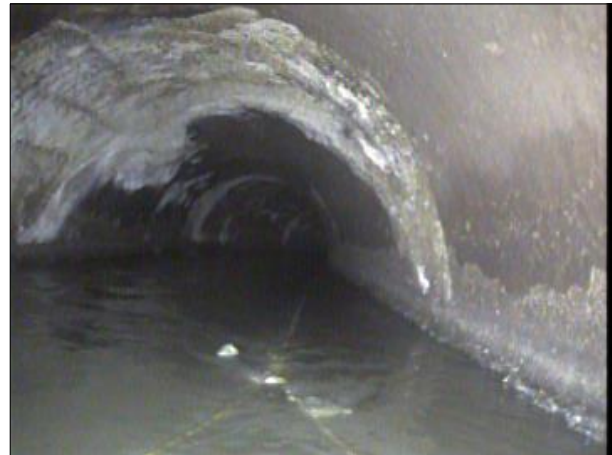
Photo: PWC-2103892-01-AMH '016462'-AMH '016461'-LR at
 591.8 ft.JPG, 00:33:50
 591.8FT, Alignment Right, 20°

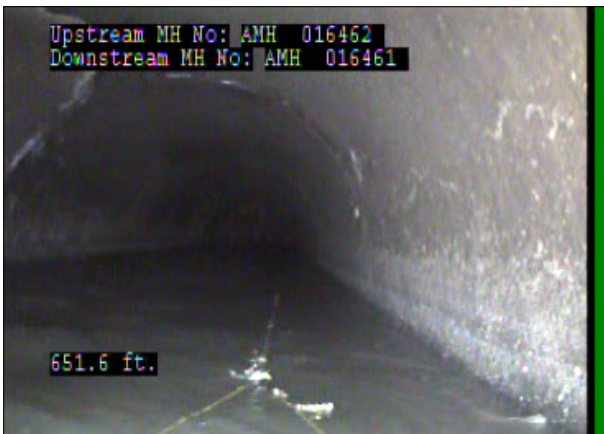
Photo: 016462_D_016461_SRI_651.5_45_A.jpg, 00:37:19
 651.5FT, Surface Roughness Increased, from 08 to 04
 o'clock, within 8 inches: NO

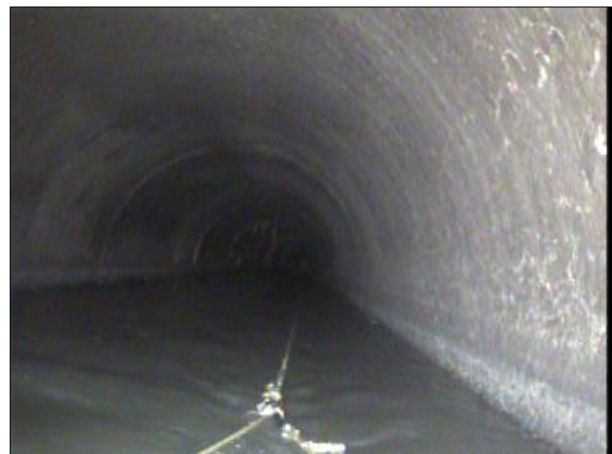
Photo: PWC-2103892-01-AMH '016462'-AMH '016461'-SRI at
 651.5 ft.JPG, 00:37:19
 651.5FT, Surface Roughness Increased, from 08 to 04
 o'clock, within 8 inches: NO

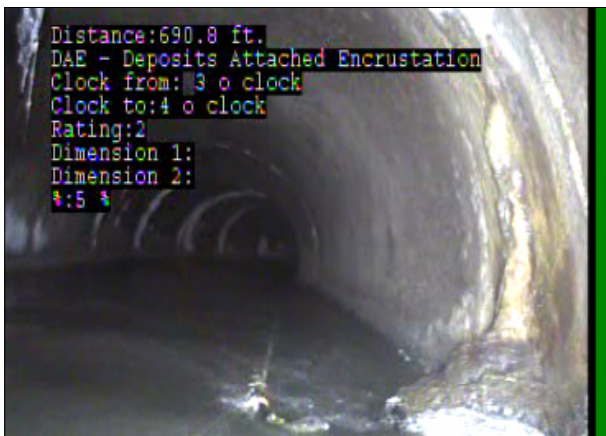
Photo: 016462_D_016461_DAE_690.8_46_A.jpg, 00:40:07
 690.8FT, Deposits Attached Encrustation, 5% of cross sectional area, from 03 to 04 o'clock, within 8 inches: NO

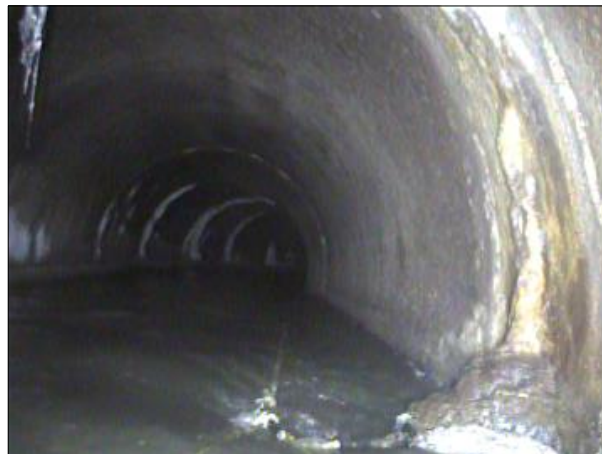
Photo: PWC-2103892-01-AMH '016462'-AMH '016461'-DAE at 690.8 ft.JPG, 00:40:07
 690.8FT, Deposits Attached Encrustation, 5% of cross sectional area, from 03 to 04 o'clock, within 8 inches: NO

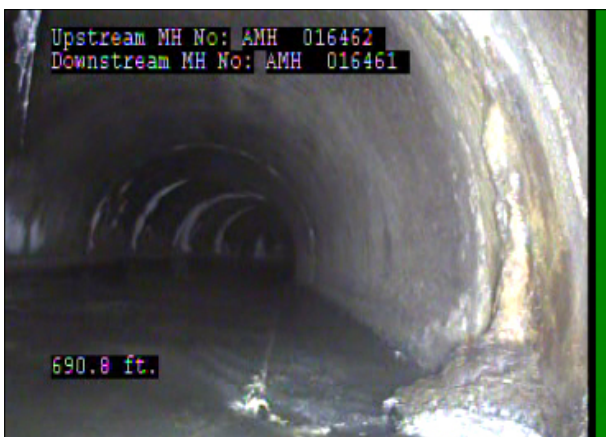
Photo: 016462_D_016461_LR_690.8_47_A.jpg, 00:40:26
 690.8FT, Alignment Right, 25°

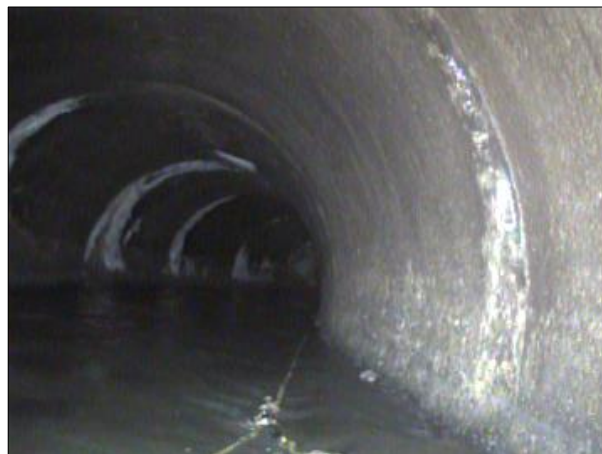
Photo: PWC-2103892-01-AMH '016462'-AMH '016461'-LR at 690.8 ft.JPG, 00:40:26
 690.8FT, Alignment Right, 25°

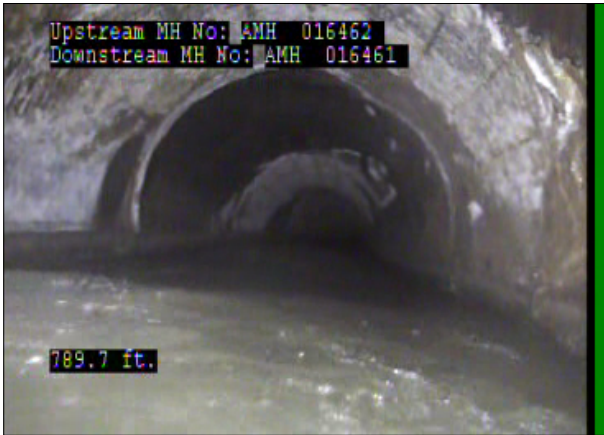
Photo: 016462_D_016461_SSS_789.7_48_A.jpg, 00:45:32
789.7FT, Surface Spalling, from 08 to 04 o'clock, within 8 inches: NO

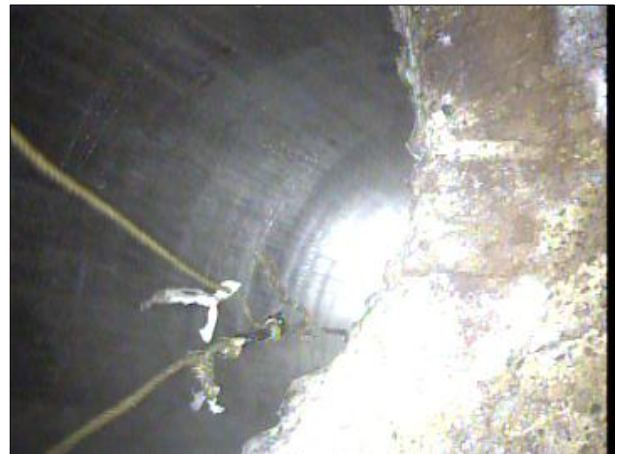
Photo: PWC-2103892-01-AMH '016462'-AMH '016461'-AMH at 792.2 ft.JPG, 00:46:53
792.2FT, Manhole

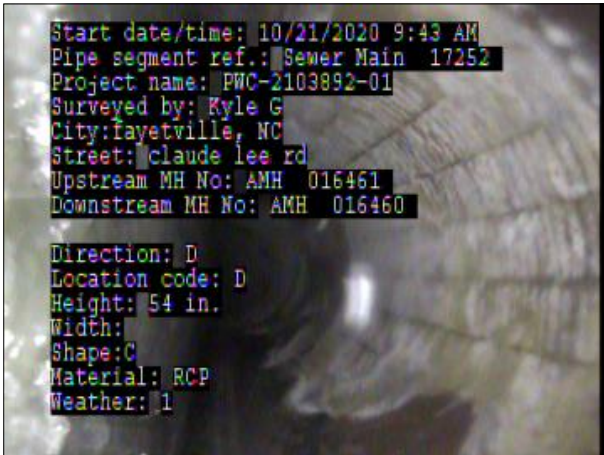
Photo: PWC-2103892-01-AMH '016461'-AMH '016460'-AMH at 0.0 ft.JPG
 OFT, Manhole

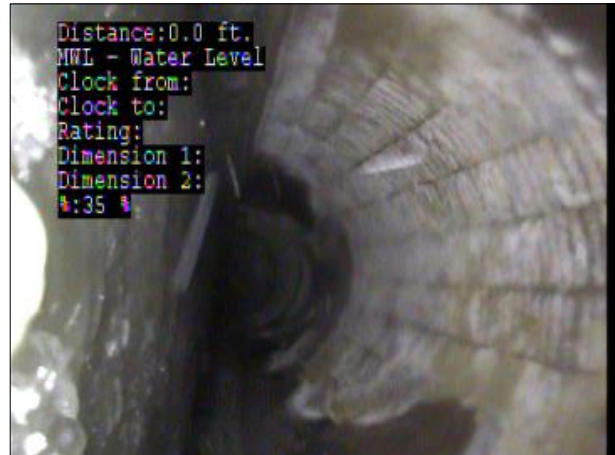
Photo: PWC-2103892-01-AMH '016461'-AMH '016460'-MWL at 0.0 ft.JPG
 OFT, Water Level, 35% of cross sectional area

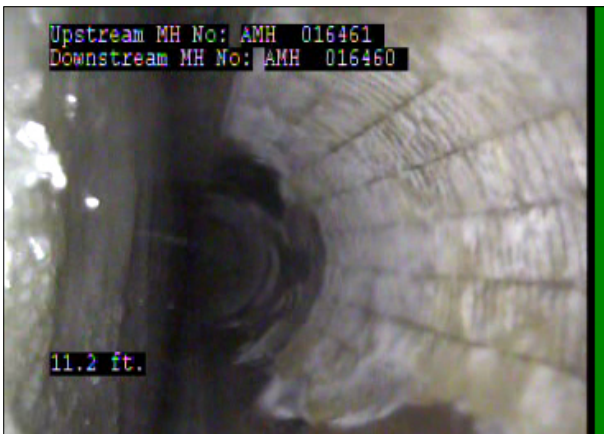
Photo: 016461_D_016460_SRC_11.2_53_A.jpg, 00:00:45
 11.2FT, Surface Reinforcement Corroded, from 09 to 03 o'clock, within 8 inches: NO

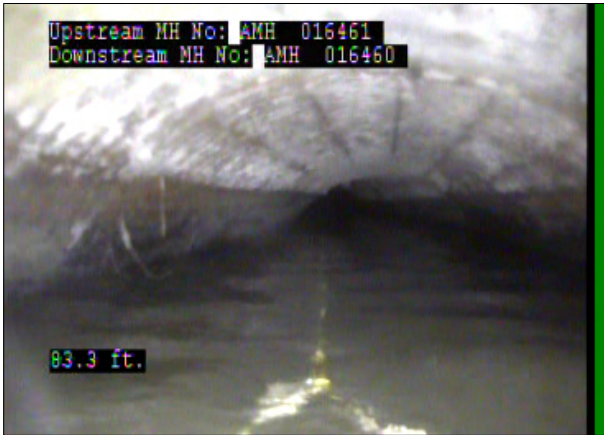
Photo: 016461_D_016460_LL_83_54_A.jpg, 00:05:02
83FT, Alignment Left, 25°

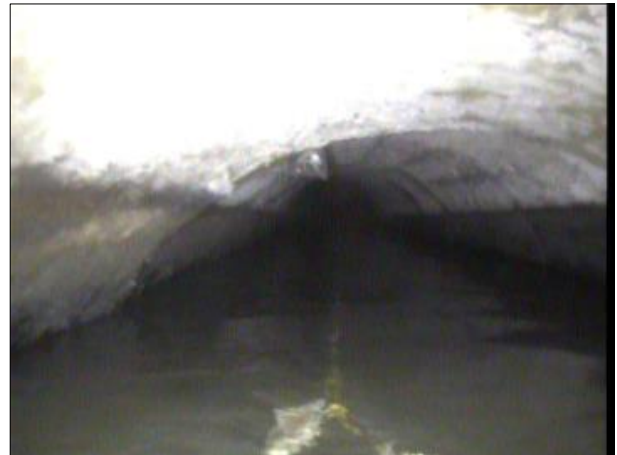
Photo: PWC-2103892-01-AMH '016461'-AMH '016460'-LL at
83.0 ft.JPG, 00:05:02
83FT, Alignment Left, 25°

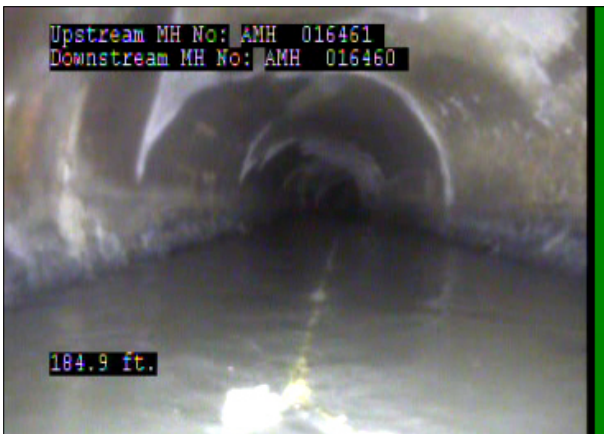
Photo: 016461_D_016460_LR_183.6_55_A.jpg, 00:08:35
183.6FT, Alignment Right, 15°

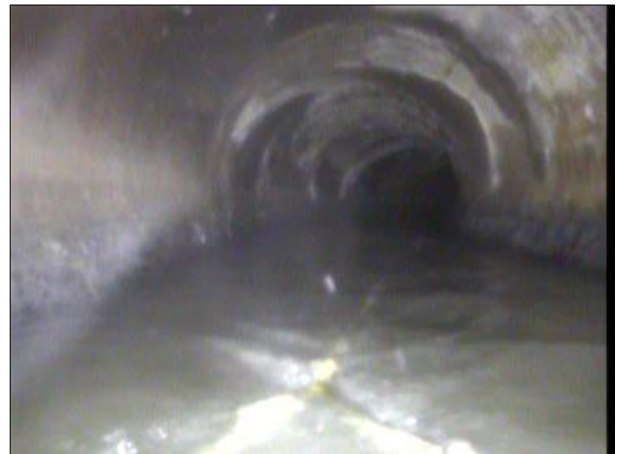
Photo: PWC-2103892-01-AMH '016461'-AMH '016460'-LR at
183.6 ft.JPG, 00:08:35
183.6FT, Alignment Right, 15°

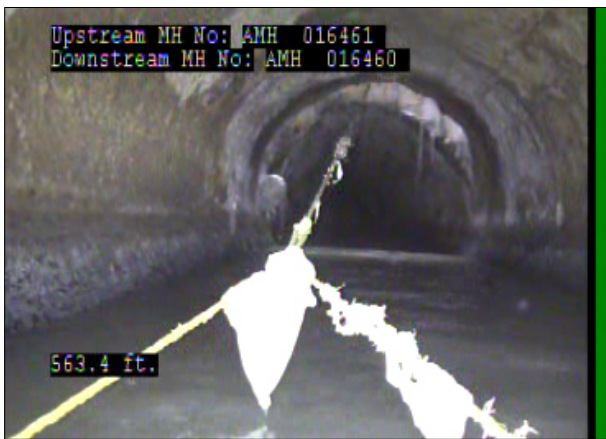
Photo: 016461_D_016460_SRC_563.4_56_A.jpg, 00:27:26
 563.4FT, Surface Reinforcement Corroded, from 09 to 03 o'clock, within 8 inches: NO

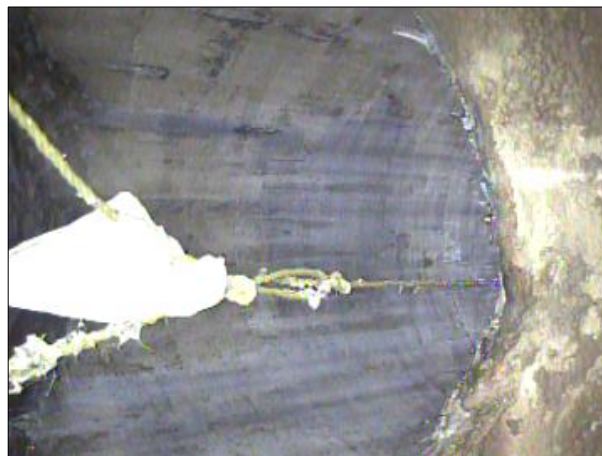
Photo: PWC-2103892-01-AMH '016461'-AMH '016460'-AMH at 570.4 ft.JPG, 00:30:09
 570.4FT, Manhole

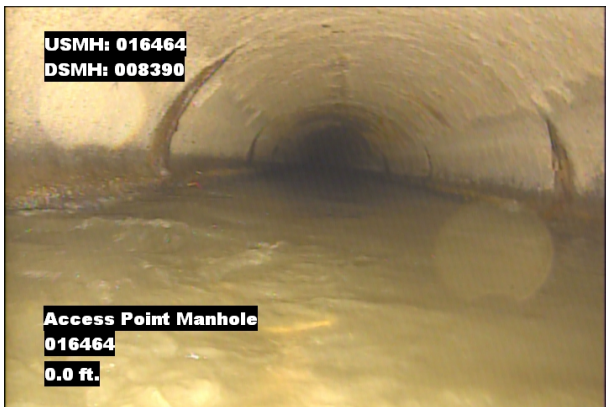
Photo: 016464_D_008390_AMH_0.jpg, VCR No.: 1
 0FT, Manhole

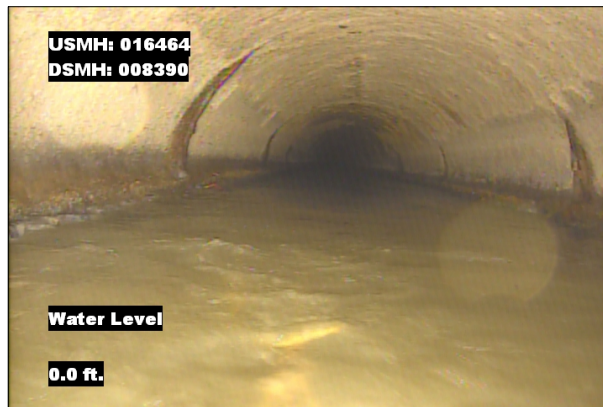
Photo: 016464_D_008390_MWL_0.jpg, VCR No.: 1
 0FT, Water Level, 45% of cross sectional area

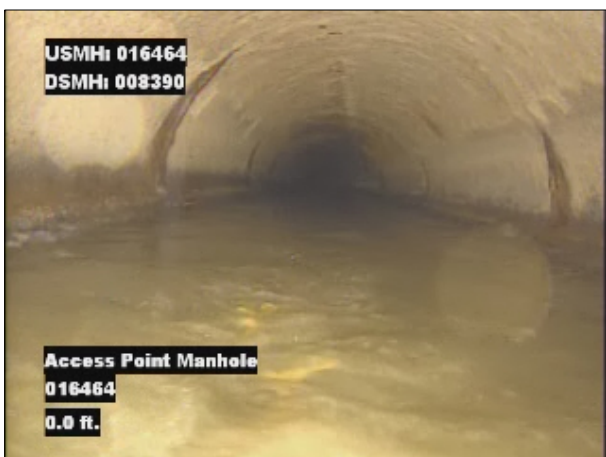
Photo: 016464_D_008390_SAV_0.2.jpg, VCR No.: 1
 0.2FT, Surface Aggregate Visible, from 07 to 05 o'clock,
 within 8 inches of joint: YES, Start

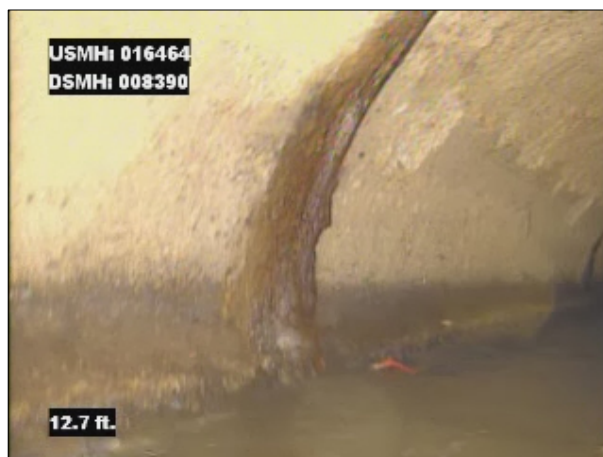
Photo: 016464_D_008390_DAE_13.jpg, VCR No.: 1
 13FT, Deposits Attached Encrustation, 5 %of cross sectional
 area, from 07 to 05 o'clock, , within 8 inches of joint: YES

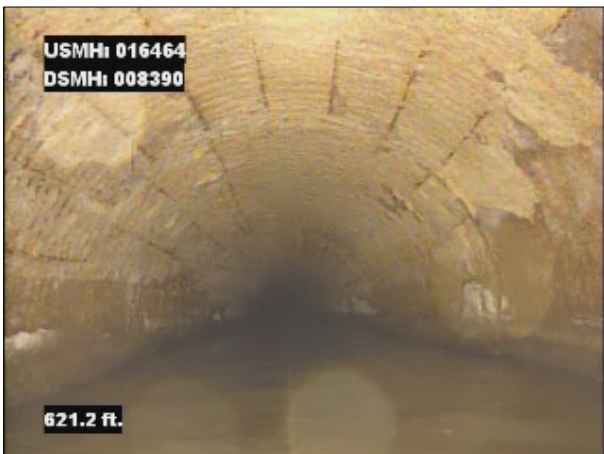
Photo: 016464_D_008390_SRV_621.jpg, VCR No.: 1
 621FT, Surface Reinforcement Visible, from 08 to 04 o'clock, within 8 inches of joint: NO, Finish

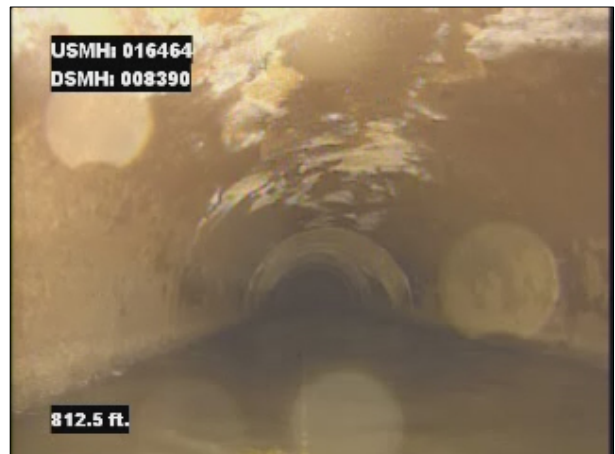
Photo: 016464_D_008390_SRV_812.jpg, VCR No.: 1
 812FT, Surface Reinforcement Visible, from 08 to 04 o'clock, within 8 inches of joint: NO, Finish

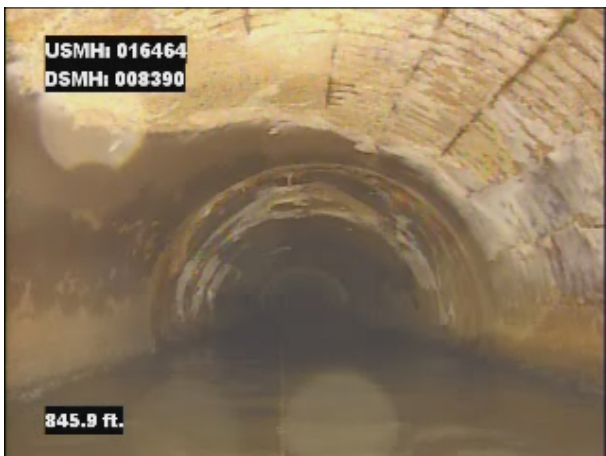
Photo: 016464_D_008390_SRV_845.jpg, VCR No.: 1
 845FT, Surface Reinforcement Visible, from 11 to 04 o'clock,
 within 8 inches of joint: YES

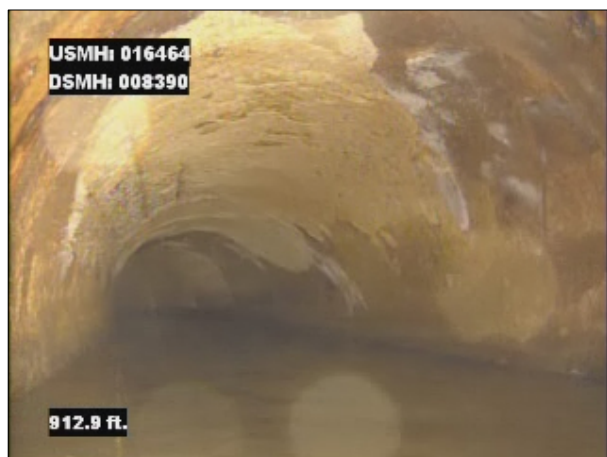
Photo: 016464_D_008390_DAE_912.jpg, VCR No.: 1
 912FT, Deposits Attached Encrustation, 5 %of cross sectional
 area, from 08 to 04 o'clock, , within 8 inches of joint: YES

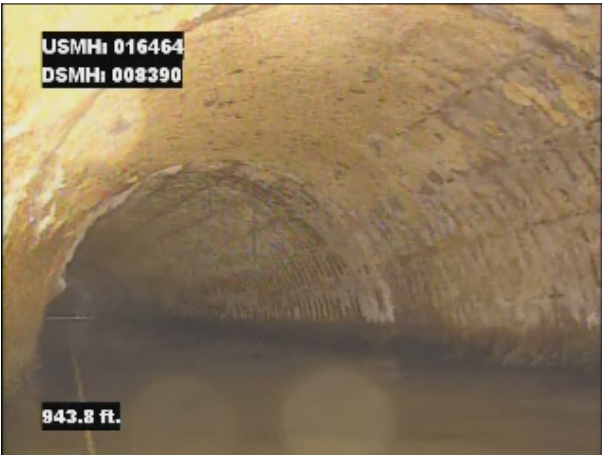
Photo: 016464_D_008390_SRV_943.jpg, VCR No.: 1
 943FT, Surface Reinforcement Visible, from 08 to 04 o'clock, within 8 inches of joint: YES, Start

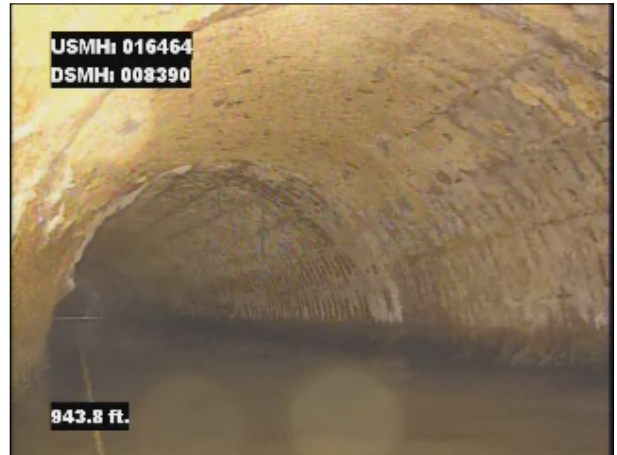
Photo: 016464_D_008390_LL_943.jpg, VCR No.: 1
 943FT, Alignment Left, 20 %

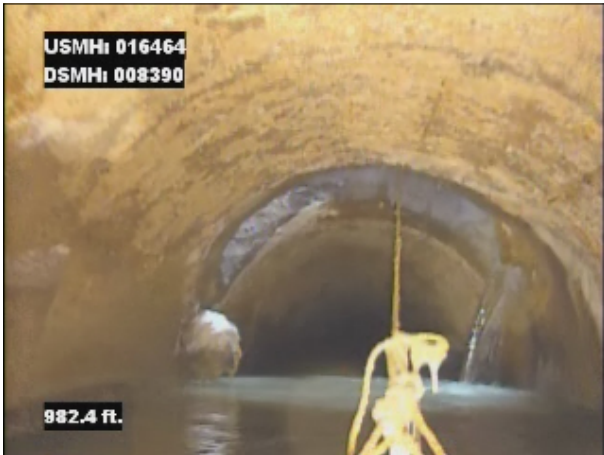
Photo: 016464_D_008390_SRV_982.jpg, VCR No.: 1
982FT, Surface Reinforcement Visible, from 08 to 04 o'clock,
within 8 inches of joint: YES, Finish

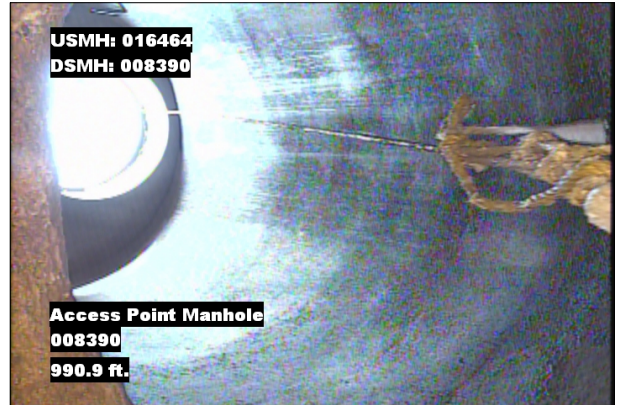
Photo: 016464_D_008390_AMH_990.9.jpg, VCR No.: 1
990.9FT, Manhole

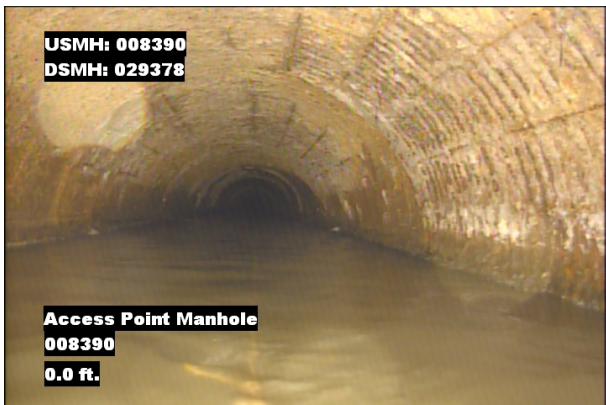
Photo: 008390_D_029378_AMH_0.jpg, VCR No.: 1
 0FT, Manhole

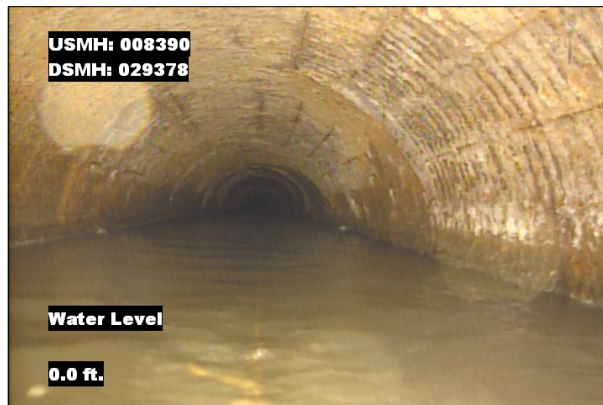
Photo: 008390_D_029378_MWL_0.jpg, VCR No.: 1
 0FT, Water Level, 45% of cross sectional area

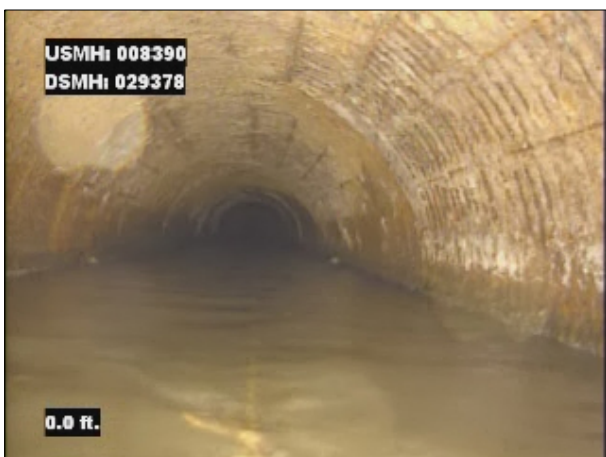
Photo: 008390_D_029378_SRV_0.1.jpg, VCR No.: 1
 0.1FT, Surface Reinforcement Visible, from 08 to 04 o'clock,
 within 8 inches of joint: NO, Start

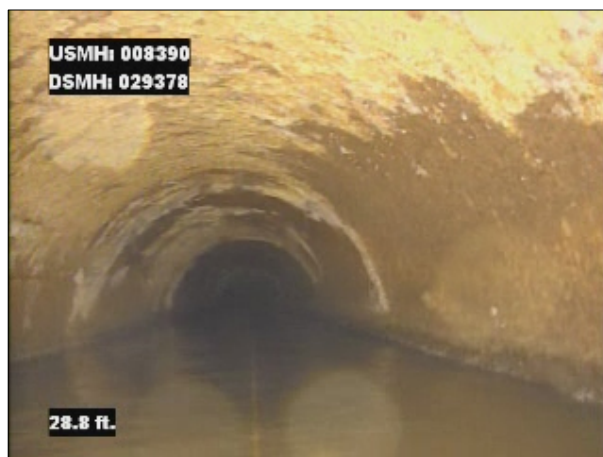
Photo: 008390_D_029378_SRV_28.7.jpg, VCR No.: 1
 28.7FT, Surface Reinforcement Visible, from 08 to 04 o'clock,
 within 8 inches of joint: NO, Finish

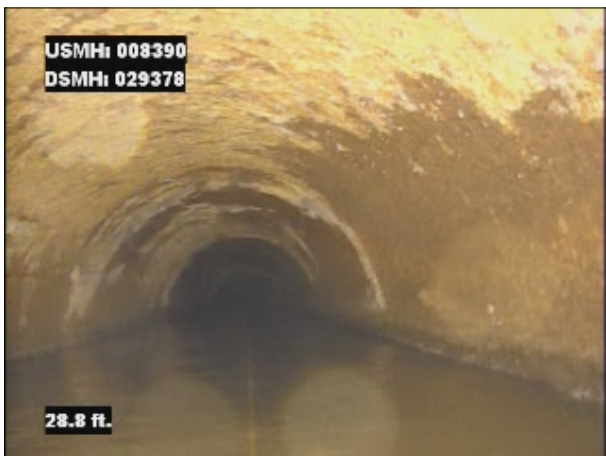
Photo: 008390_D_029378_SAV_28.8.jpg, VCR No.: 1
 28.8FT, Surface Aggregate Visible, from 08 to 04 o'clock,
 within 8 inches of joint: NO, Start

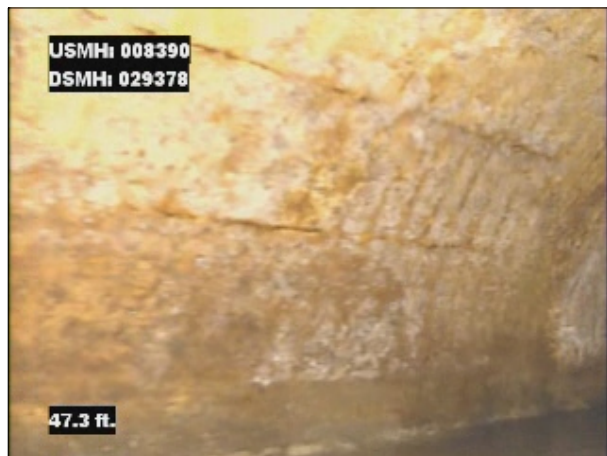
Photo: 008390_D_029378_SRV_47.3.jpg, VCR No.: 1
 47.3FT, Surface Reinforcement Visible, from 08 to 12 o'clock,
 within 8 inches of joint: YES

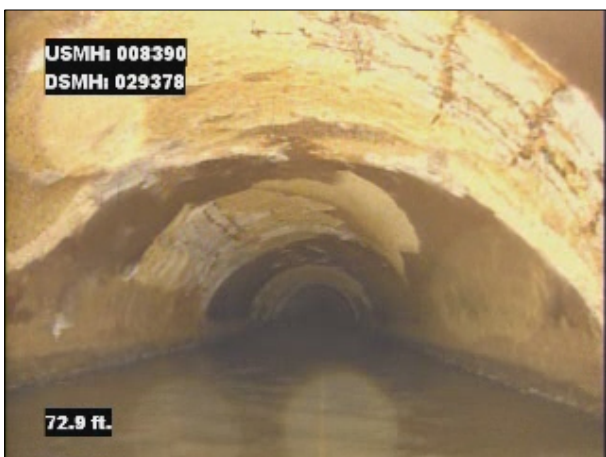
Photo: 008390_D_029378_SRV_72.9.jpg, VCR No.: 1
 72.9FT, Surface Reinforcement Visible, from 08 to 04 o'clock,
 within 8 inches of joint: NO, Start

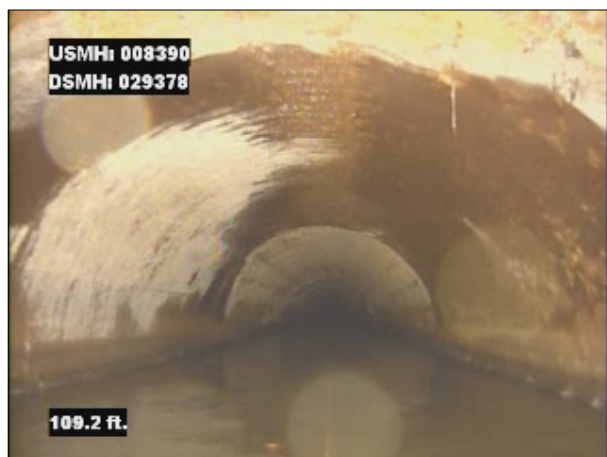
Photo: 008390_D_029378_SAV_109.2.jpg, VCR No.: 1
 109.2FT, Surface Aggregate Visible, from 08 to 04 o'clock,
 within 8 inches of joint: NO, Finish

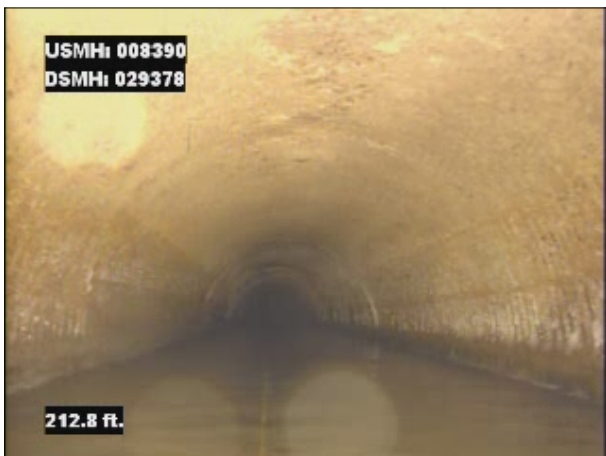
Photo: 008390_D_029378_SRV_212.jpg, VCR No.: 1
 212FT, Surface Reinforcement Visible, from 08 to 04 o'clock,
 within 8 inches of joint: NO, Finish

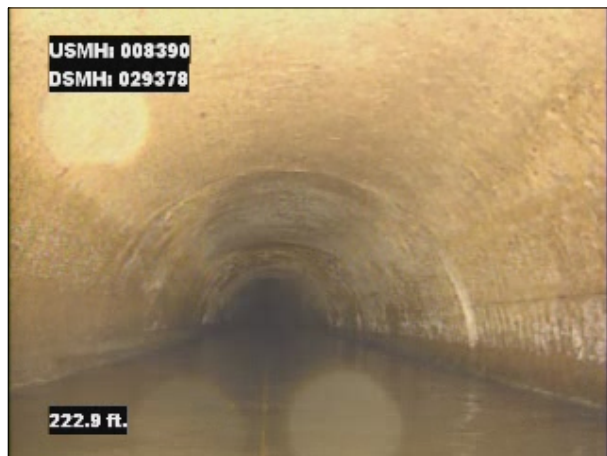
Photo: 008390_D_029378_SAV_222.jpg, VCR No.: 1
 222FT, Surface Aggregate Visible, from 07 to 05 o'clock,
 within 8 inches of joint: YES, Start

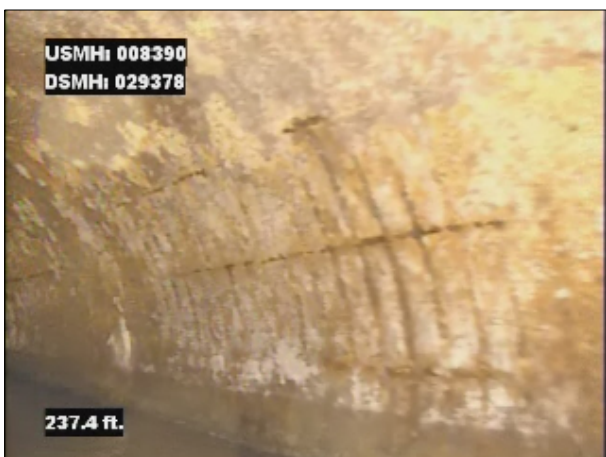
Photo: 008390_D_029378_SRV_237.jpg, VCR No.: 1
 237FT, Surface Reinforcement Visible, from 08 to 04 o'clock,
 within 8 inches of joint: NO, Start

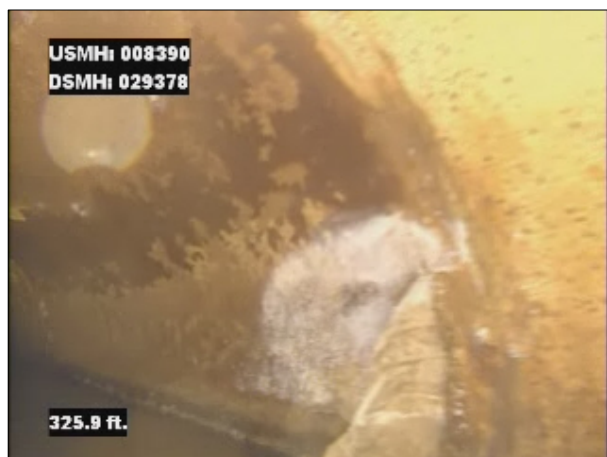
Photo: 008390_D_029378_DAR_325.jpg, VCR No.: 1
 325FT, Deposits Attached Ragging, 5 %of cross sectional
 area, from 03 to 04 o'clock, , within 8 inches of joint: YES

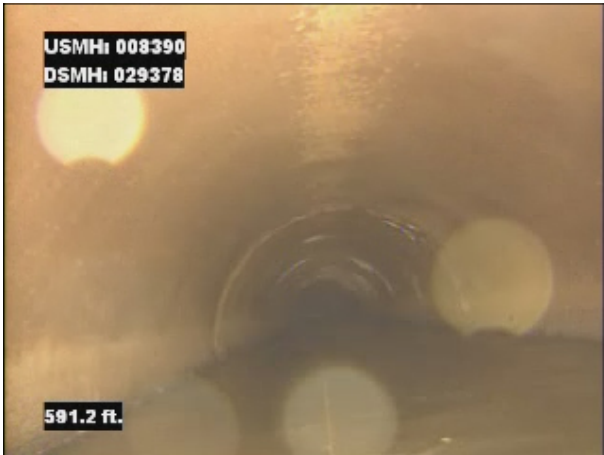
Photo: 008390_D_029378_SRV_591.jpg, VCR No.: 1
 591FT, Surface Reinforcement Visible, from 08 to 04 o'clock,
 within 8 inches of joint: NO, Finish

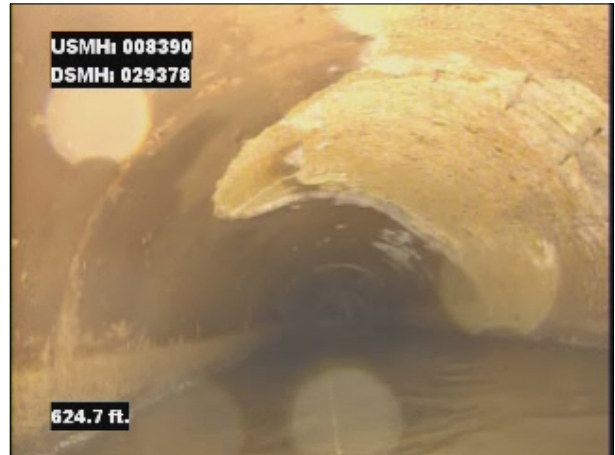
Photo: 008390_D_029378_SRV_624.jpg, VCR No.: 1
 624FT, Surface Reinforcement Visible, from 01 to 04 o'clock,
 within 8 inches of joint: NO

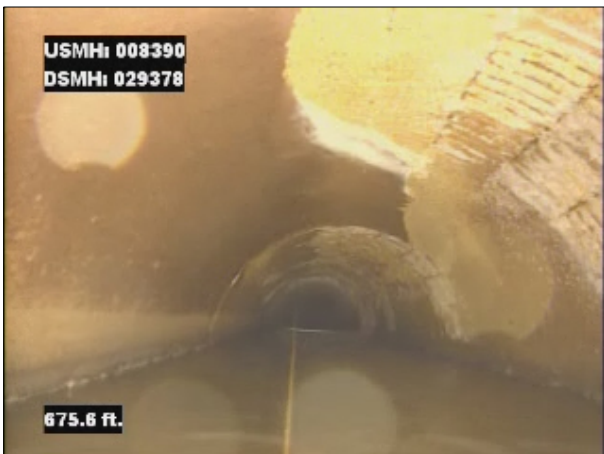
Photo: 008390_D_029378_SRV_675.jpg, VCR No.: 1
 675FT, Surface Reinforcement Visible, from 08 to 04 o'clock,
 within 8 inches of joint: NO, Start

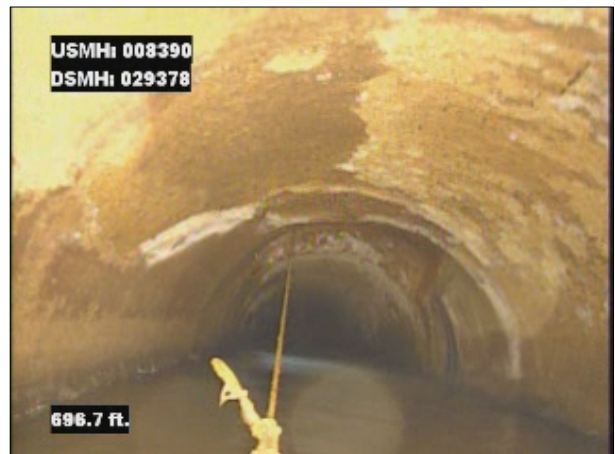
Photo: 008390_D_029378_SRV_698.jpg, VCR No.: 1
 698FT, Surface Reinforcement Visible, from 08 to 04 o'clock,
 within 8 inches of joint: NO, Finish

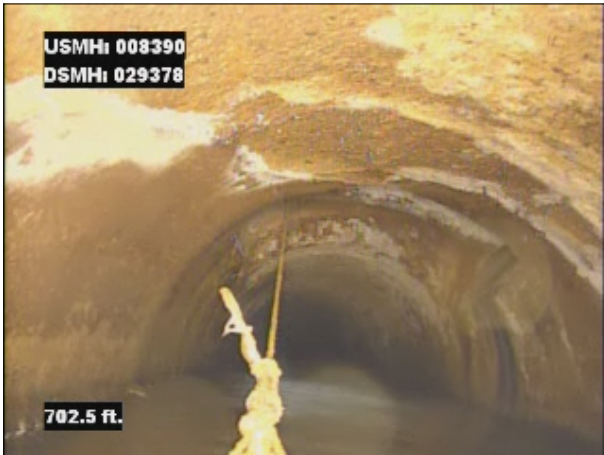
Photo: 008390_D_029378_SAV_702.5.jpg, VCR No.: 1
702.5FT, Surface Aggregate Visible, from 07 to 05 o'clock,
within 8 inches of joint: YES, Finish

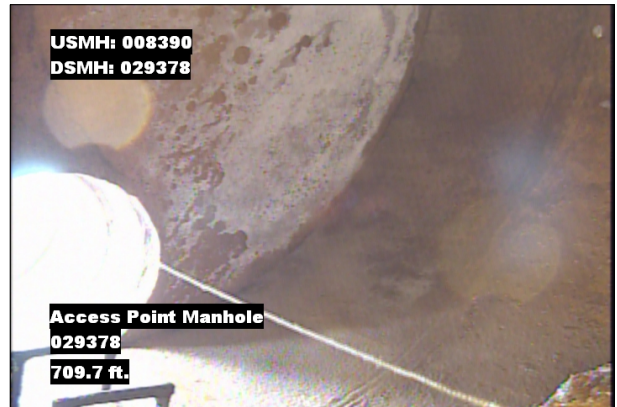
Photo: 008390_D_029378_AMH_709.7.jpg, VCR No.: 1
709.7FT, Manhole

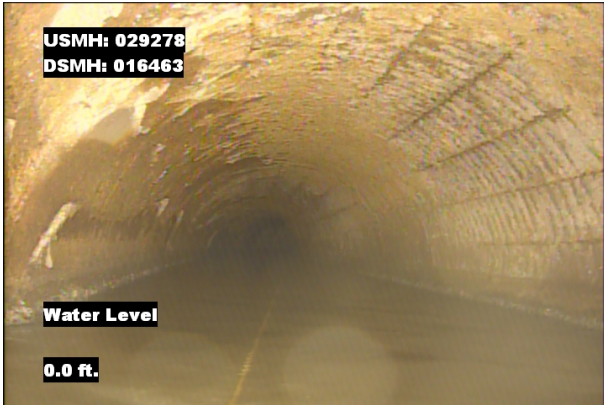
Photo: 029378_D_016463_MWL_0.jpg, VCR No.: 1
 0FT, Water Level, 40% of cross sectional area

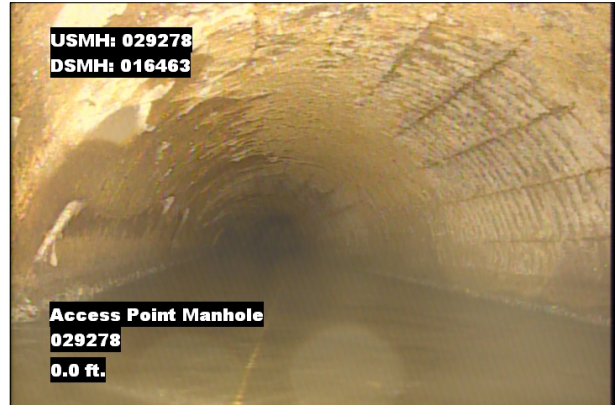
Photo: 029378_D_016463_AMH_0.jpg, VCR No.: 1
 0FT, Manhole

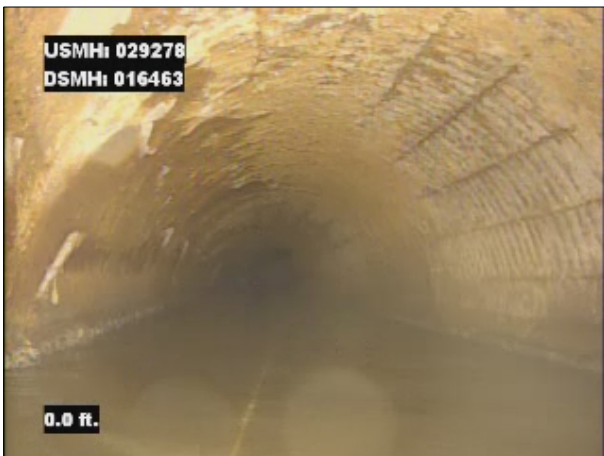
Photo: 029378_D_016463_SRV_1.jpg, VCR No.: 1
 1FT, Surface Reinforcement Visible, from 08 to 04 o'clock,
 within 8 inches of joint: NO, Start

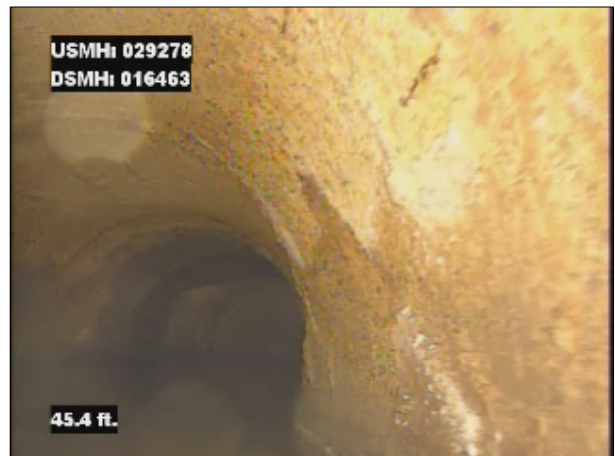
Photo: 029378_D_016463_LR_45.jpg, VCR No.: 1
 45FT, Alignment Right, 25 %

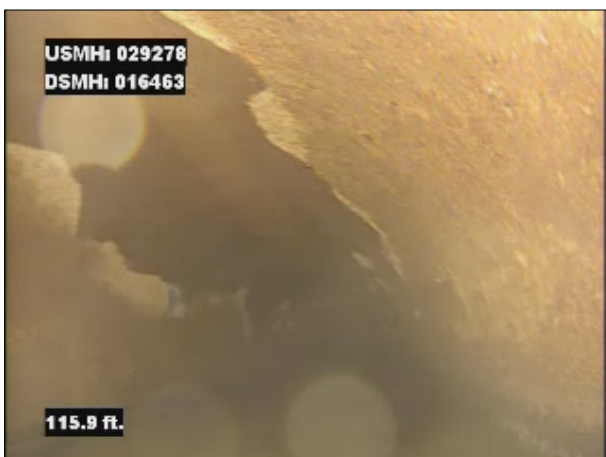
Photo: 029378_D_016463_SAV_115.jpg, VCR No.: 1
 115FT, Surface Aggregate Visible, from 08 to 04 o'clock, within 8 inches of joint: NO, Start

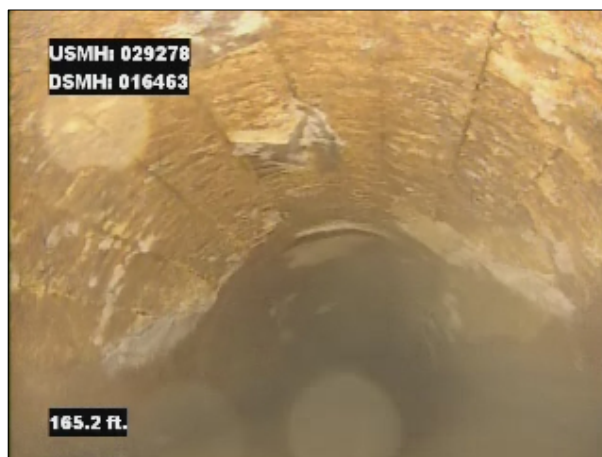
Photo: 029378_D_016463_SRV_165.jpg, VCR No.: 1
 165FT, Surface Reinforcement Visible, from 08 to 04 o'clock, within 8 inches of joint: NO

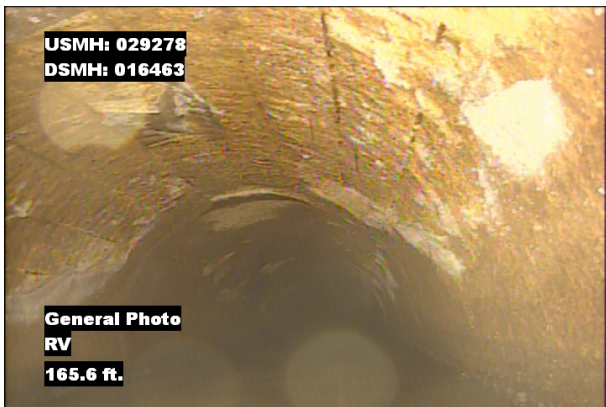
Photo: 029378_D_016463_MGP_165.6.jpg, VCR No.: 1
165.6FT, General Photograph

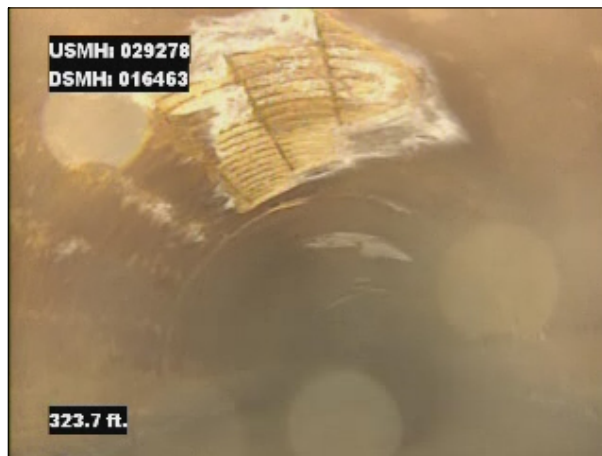
Photo: 029378_D_016463_SRV_323.jpg, VCR No.: 1
323FT, Surface Reinforcement Visible, from 10 to 01 o'clock,
within 8 inches of joint: NO

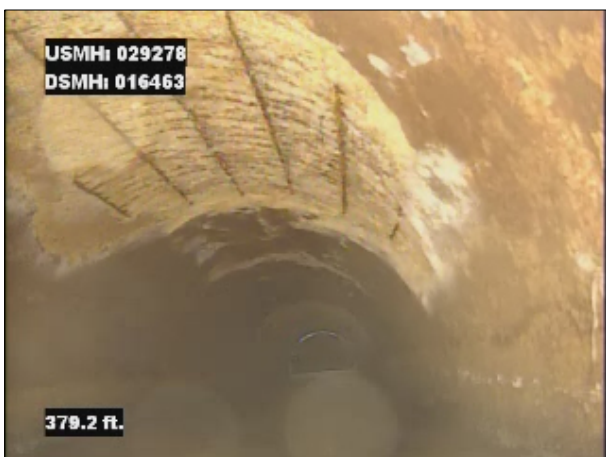
Photo: 029378_D_016463_SRV_379.jpg, VCR No.: 1
379FT, Surface Reinforcement Visible, from 10 to 02 o'clock,
within 8 inches of joint: NO

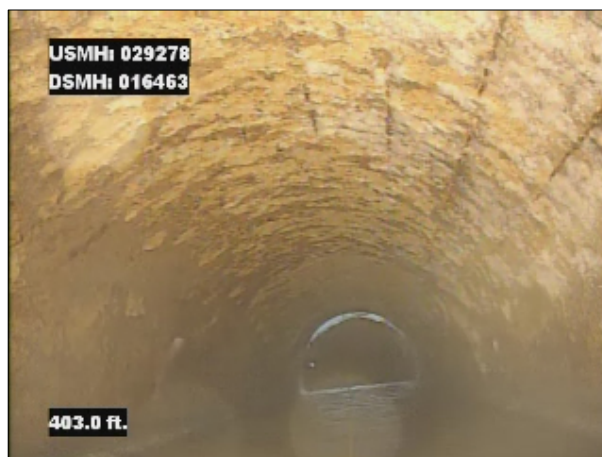
Photo: 029378_D_016463_SRV_403.jpg, VCR No.: 1
403FT, Surface Reinforcement Visible, from 10 to 02 o'clock,
within 8 inches of joint: NO

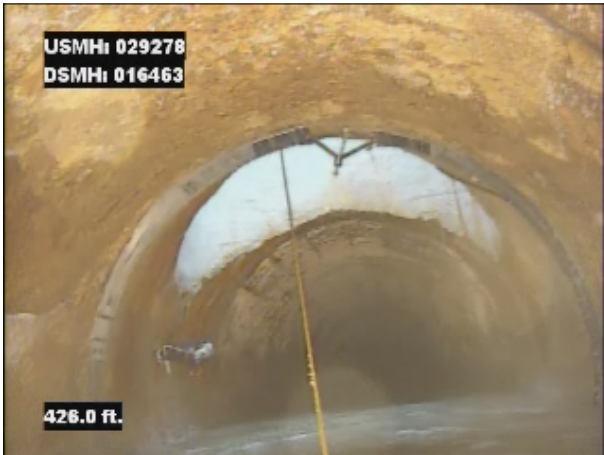
Photo: 029378_D_016463_SAV_426.jpg, VCR No.: 1
426FT, Surface Aggregate Visible, from 08 to 04 o'clock,
within 8 inches of joint: NO, Finish

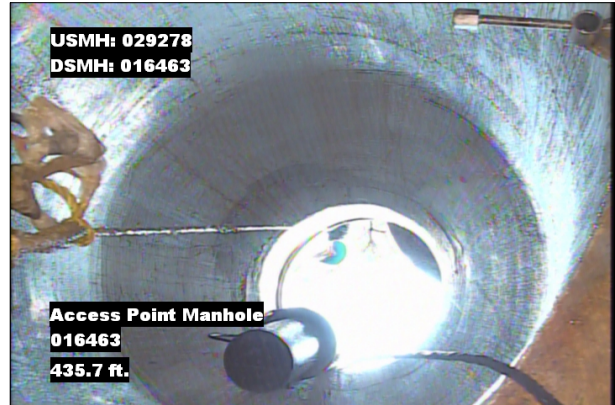
Photo: 029378_D_016463_AMH_435.7.jpg, VCR No.: 1
435.7FT, Manhole
