## FAYETTEVILLE PUBLIC WORKS COMMISSION

**Bid Title:** FY26 Water Tank Maintenance Projects

**Addendum Date:** March 31, 2026

**WATER STORAGE TANK ANNUAL INSPECTION REPORT – EXTERIOR & INTERIOR DRY**

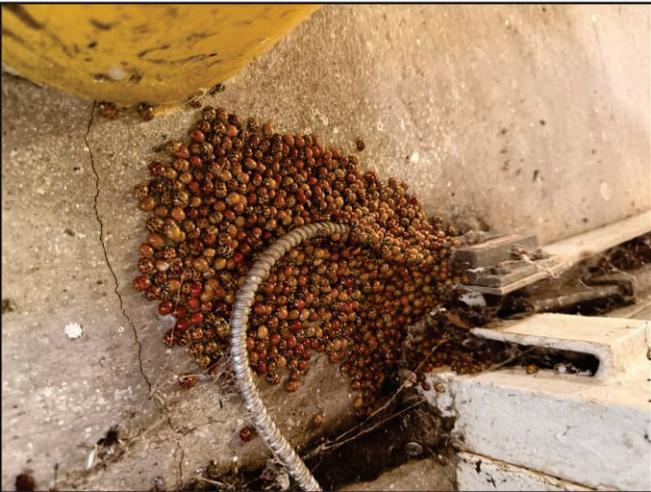
**Photo 5**  
*Ladybugs in interior dry.*

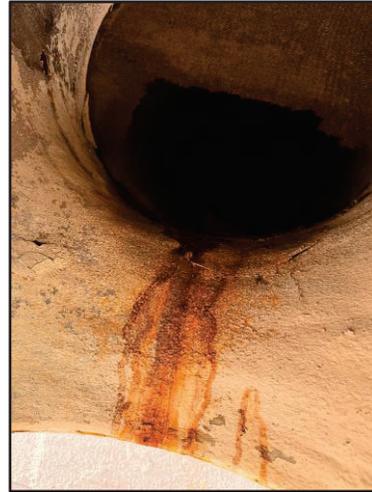
**Photo 3**  
*18" DIP overflow pipe vent screen torn.*

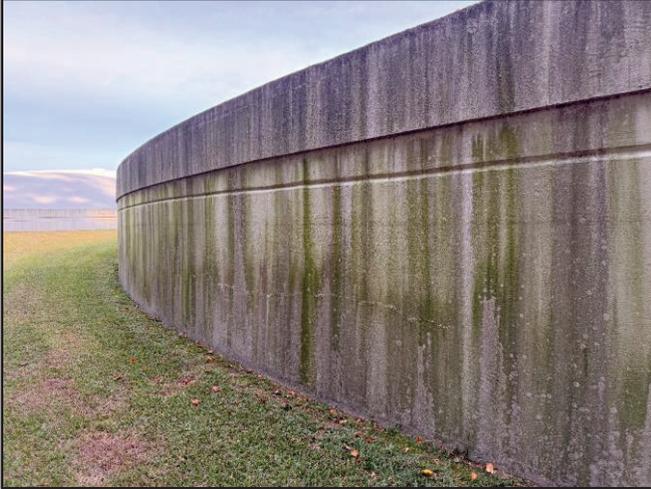
**Photo 6**  
*Mildew at northwest sidewall.*

Coating performing adequately overall, although moderate sized blisters have developed in several locations on the tank roof and sidewalls. See photos. Blisters are becoming more widespread, particularly at top of tank. Some mildew growth is present on the sidewalls of the tank at the northwest face of the tank. No recommended coating action at present time.

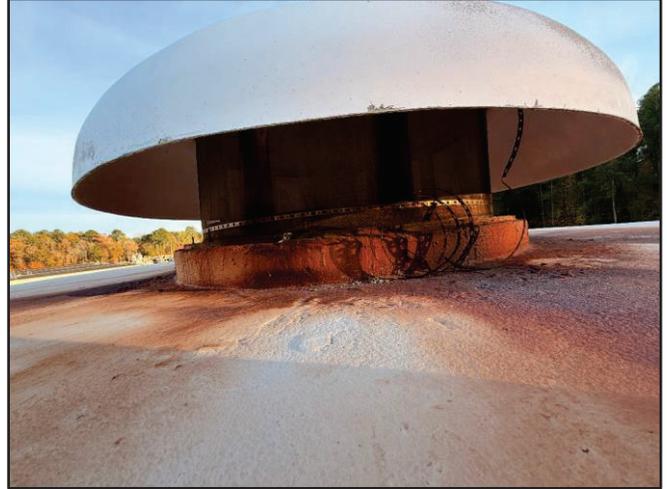
**Photo 7**  
*Top vent and staining.*

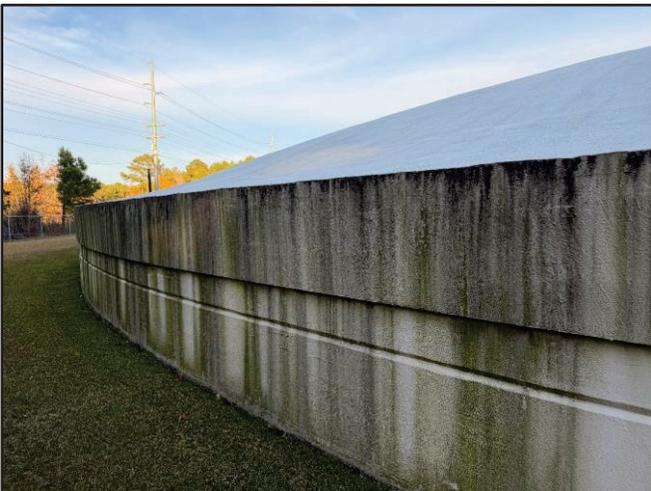
*Mildew on northwest face of sidewall.*

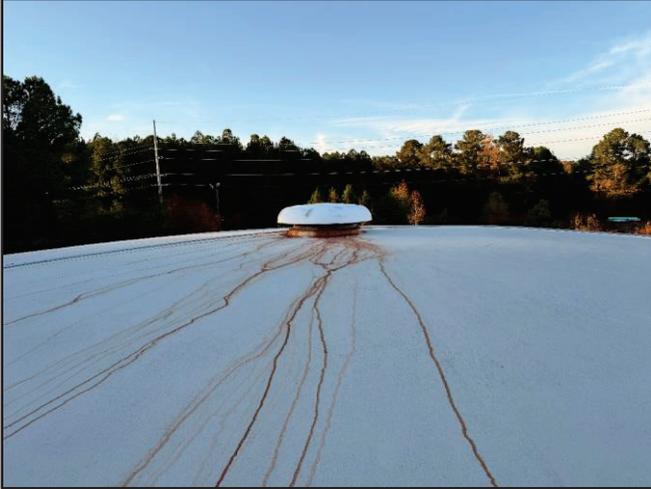
**Photo 6**  
*Staining at top of tank.*

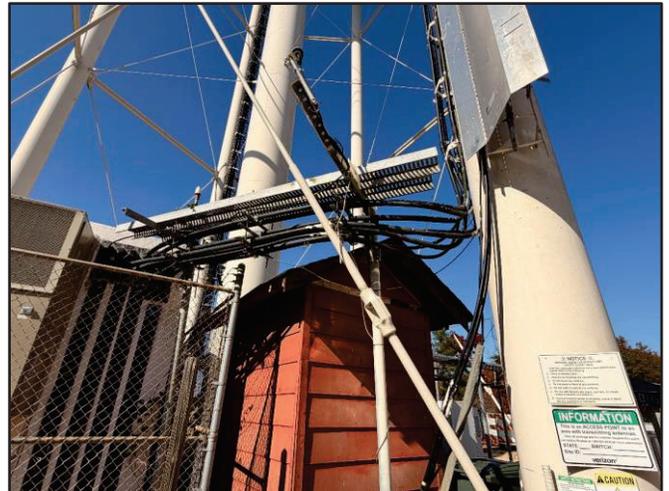
**Photo 6**  
*Base of ladder, compound and ice bridge for coax support. Heavy flying insect presence at building.*

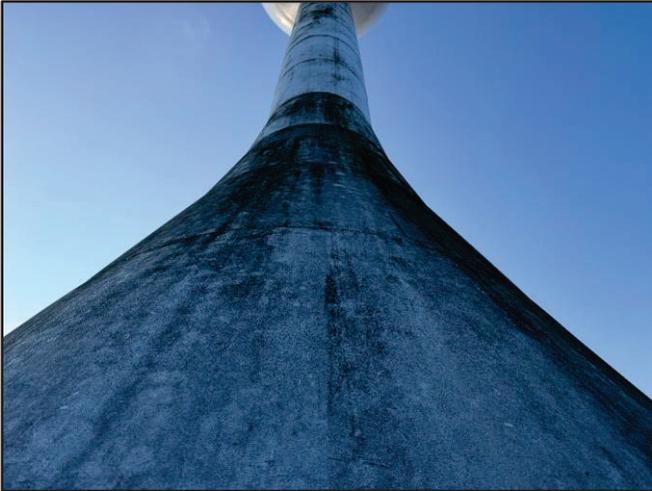
**Photo 3**  
*Mildew accumulation.*
